SNAG INSPECTION

Property address: SNAG INSPECTION SAMPLE REPORT
Johannesburg 0000

Date of inspection: 2022 / 02 / 16

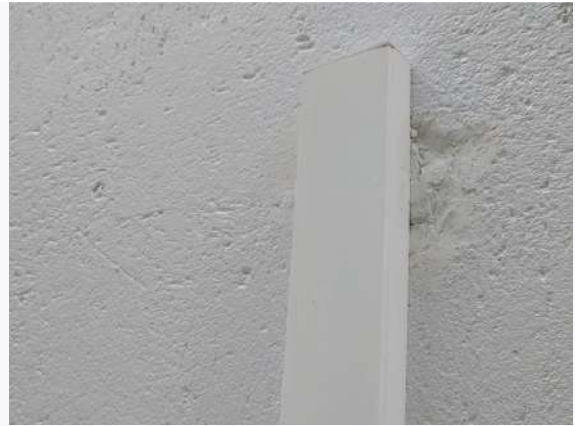
Ref	Inspectors Notes	Comment
Exteriors of the structure		
2.1	Exterior walls	<p>Hole drilled through wall for electrical supply for external aircon unit, untidy finishing</p> <p>DEFECTIVE ITEMS</p>

Ref # 2.1 - Untidy finishing

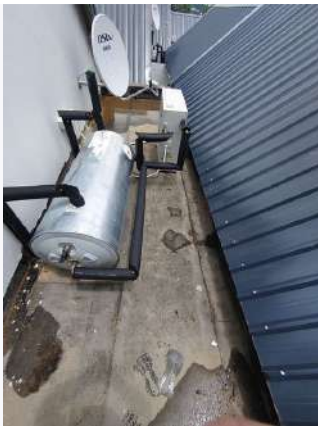
Ref	Inspectors Notes	Comment
4.1	Roof covering	Roof slab slope directional flow for drainage could not be verified when checked with a level, the fall should be min 1:60; Water ponding on slab; Height of the drainage outlet is above the slab level and / or drainage outlet is not effective DEFECTIVE ITEMS

Ref # 4.1 - Verify roof slab slope directional flow for drainage

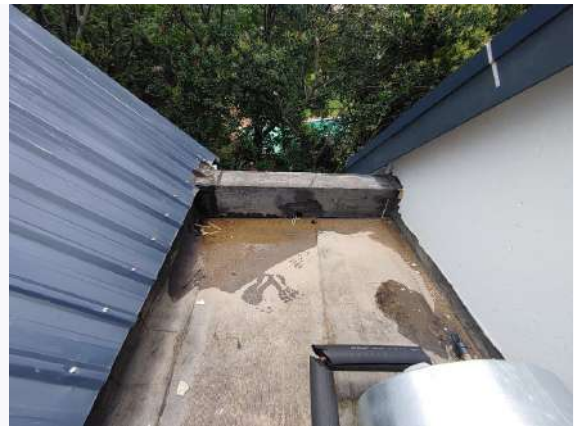
Ref # 4.1 - Water ponding on slab

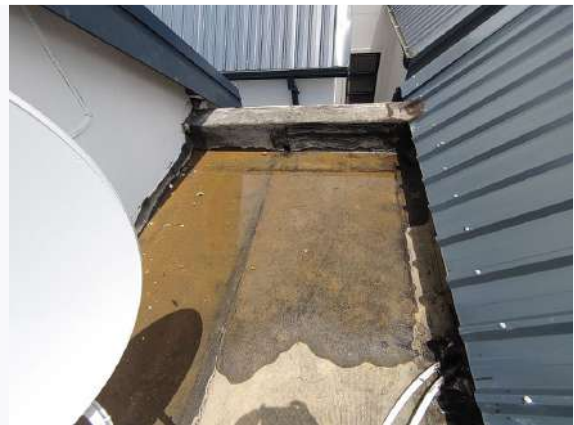
Ref # 4.1 - Water ponding on slab

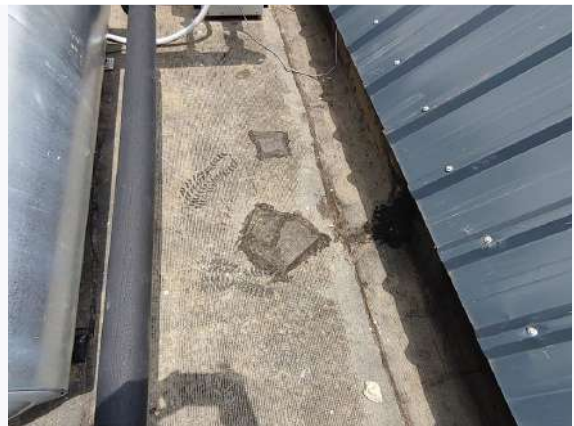
4.2	Flashing & waterproofing	Verify if the roof slab had been waterproofed as per specification; Waterproofing debonded from sub-strata in areas, resulting in air pockets between the sub-strata and waterproofing; Waterproofing on parapet wall overlapping onto adjacent metal roof; Projections through the roof slab are not waterproofed effectively and damaged in areas; Parapet walls are not waterproofed over the lip of the parapet wall resulting in active penetrating damp; Areas not waterproofed; No cover flashing observed; Remedial work done to waterproofing; Areas not waterproofed DEFECTIVE ITEMS

Ref # 4.2 - Remedial work done to waterproofing

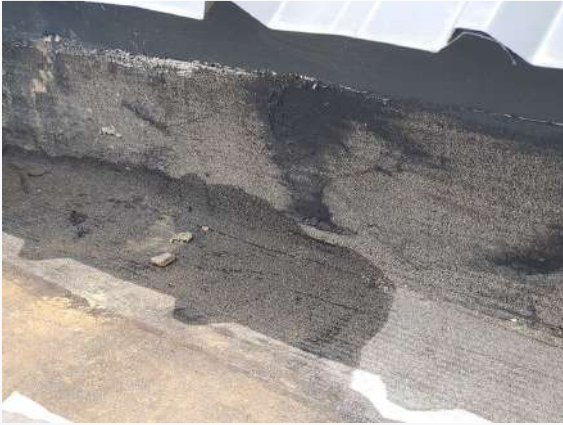
Ref # 4.2 - No cover flashing observed

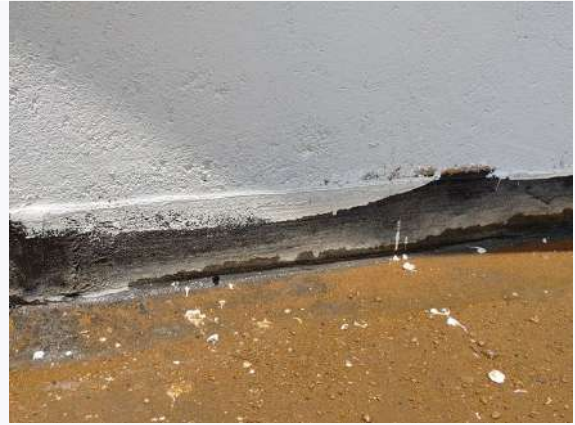
Ref # 4.2 - No cover flashing observed

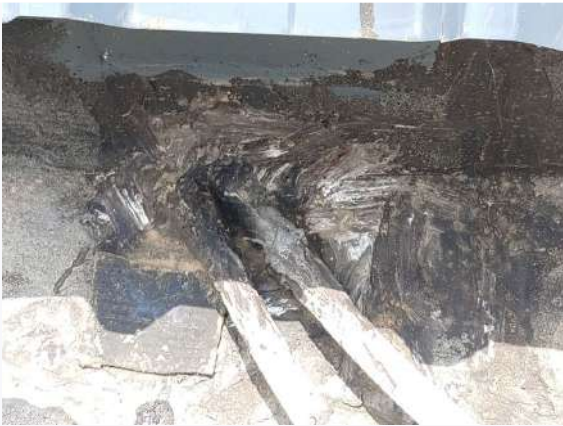
Ref # 4.2 - Projections through the roof slab are not waterproofed effectively

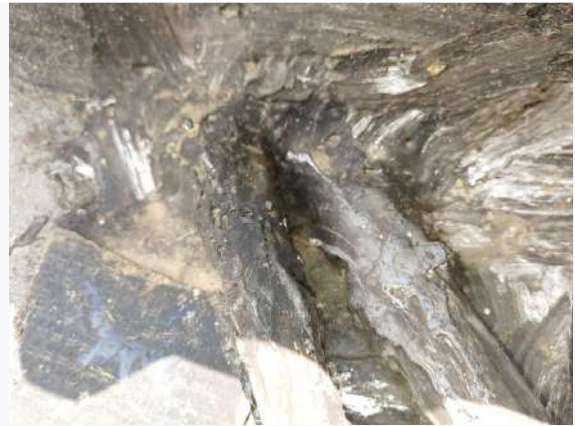
Ref # 4.2 - Projections through the roof slab are not waterproofed effectively

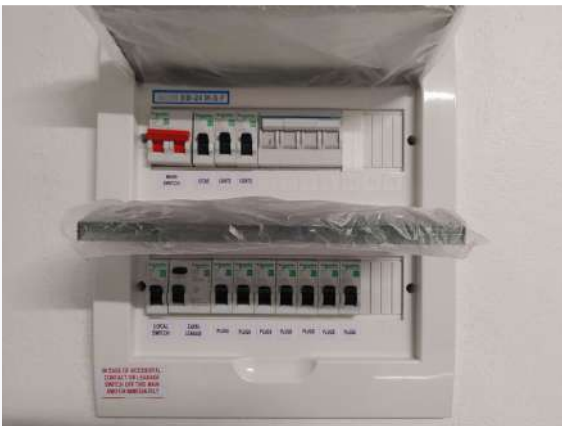
8.1	Electrical - Main DB board	No separate circuit breaker observed on main DB board and /or labeling observed for the hot water geyser DEFECTIVE ITEMS
-----	----------------------------	---

Ref # 8.1 - Main DB board

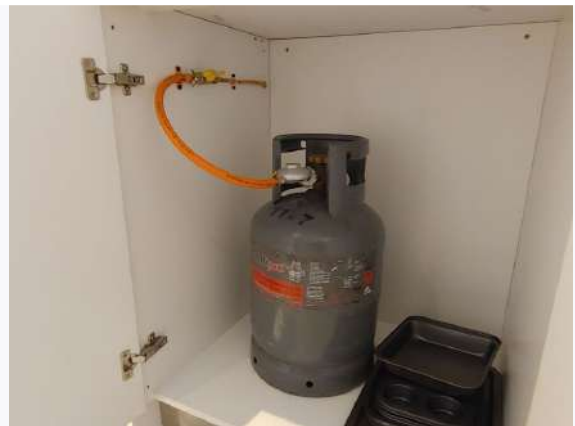
8.2	Gas bottles	Non-compliant installation; Gas bottle installation is inside the kitchen in a floor unit; No provision for ventilation provided; No signage indicating location of the shut-off valve DEFECTIVE ITEMS
-----	-------------	---

Ref # 8.2 - No provision made for ventilation

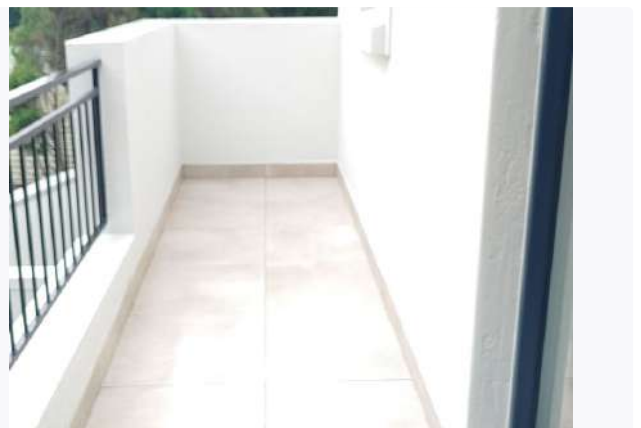
Ref # 10.2 - Verify if the balcony had been waterproofed

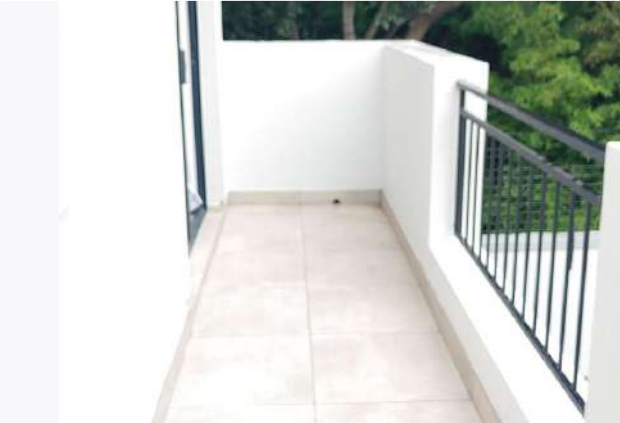
Ref # 10.2 - Verify floor slope directional flow for drainage

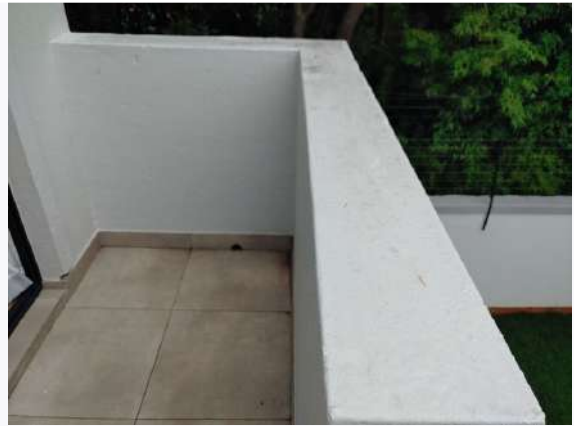
Ref # 10.2 - Top of the masonry balustrades do not appear to be waterproofed

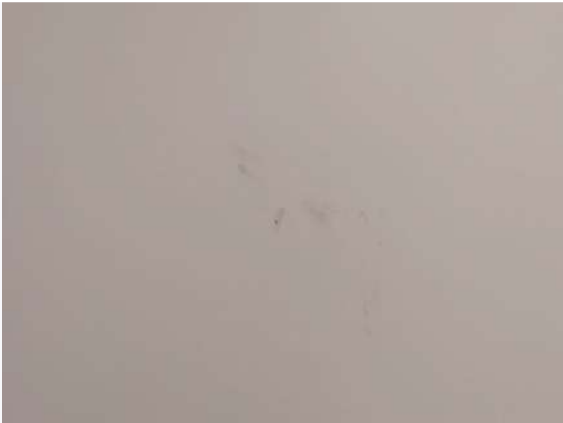
Ref # 11.1 - Scuff marks observed in areas

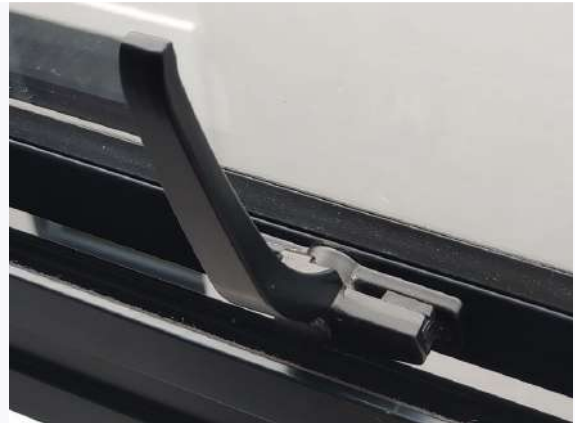
Ref # 11.2 - Window opener loose and requires adjustment

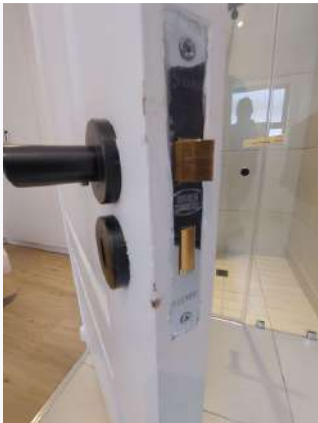
Ref # 11.3 - Paint splatter and scuff marks on the door lock sets

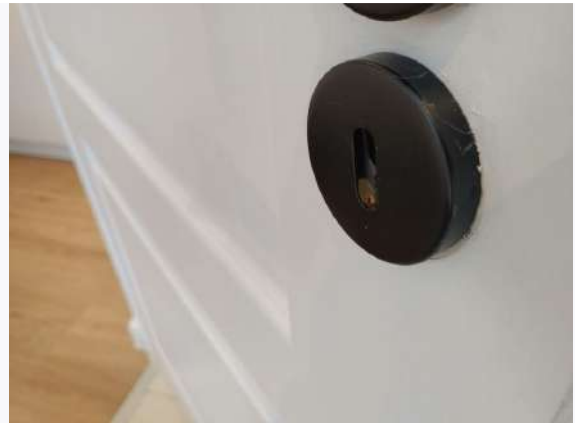
Ref # 11.3 - Paint splatter and scuff marks on the door lock sets

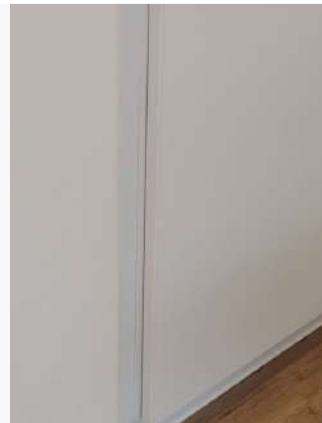
Ref # 11.4 - Cupboard doors and hinges require alignment and/or adjustment

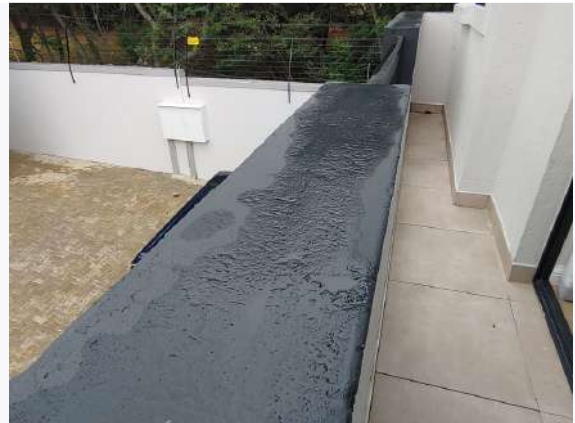
Ref # 12.1 - Top of the masonry balustrades do not appear to be waterproofed

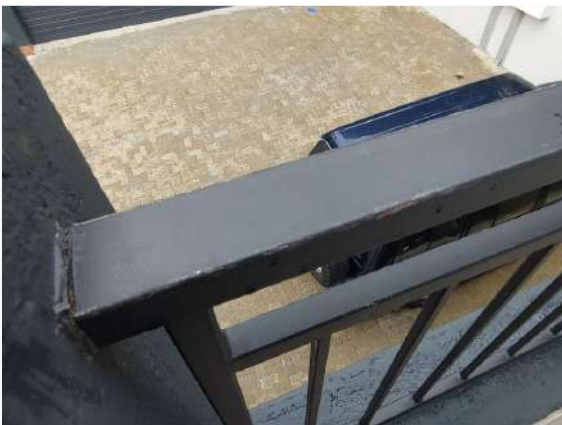
Ref # 12.1 - Rust observed on balustrade

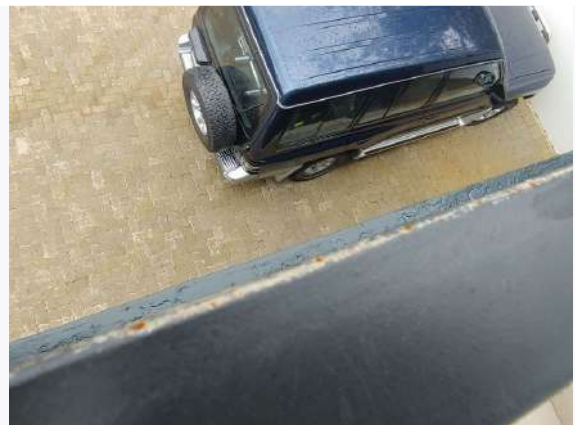
Ref # 12.1 - Rust observed on balustrade

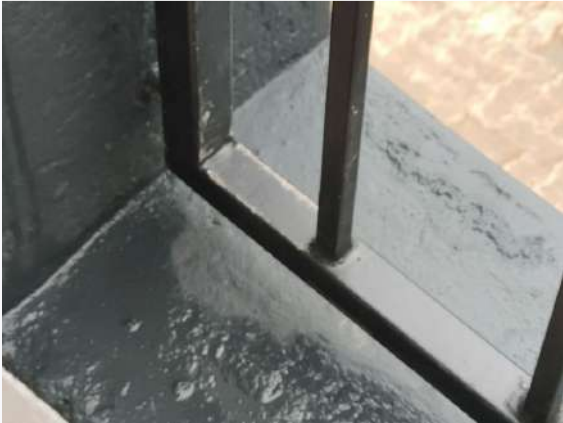
Ref # 12.1 - Rust observed on balustrade

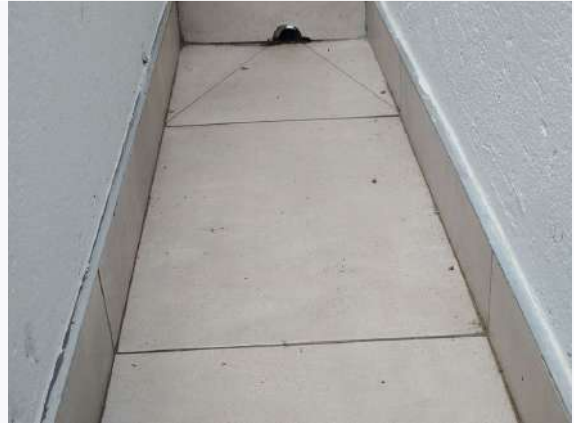
Ref # 12.1 - Verify floor slope directional flow for drainage

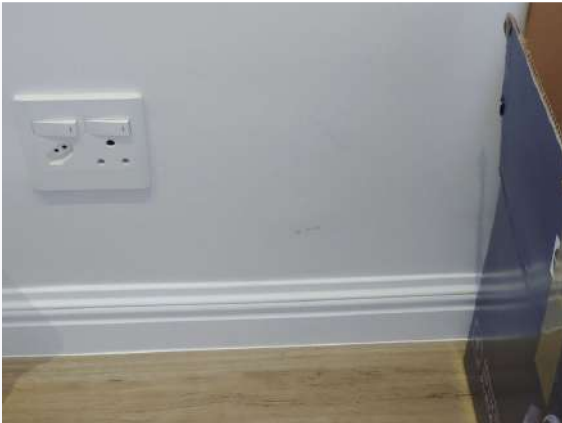
Ref # 13.1 - Scuff marks observed in areas

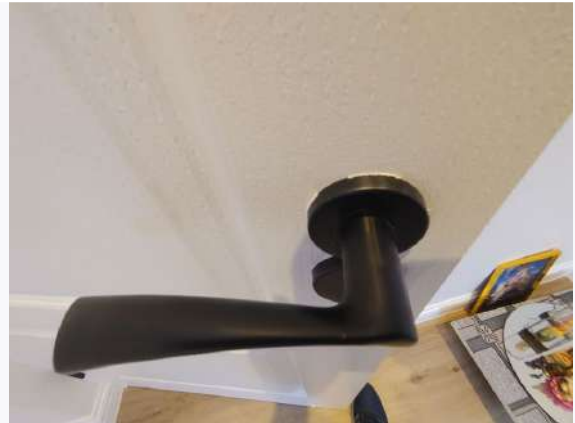
Ref # 13.2 - Paint splatter and scuff marks on the door lock sets

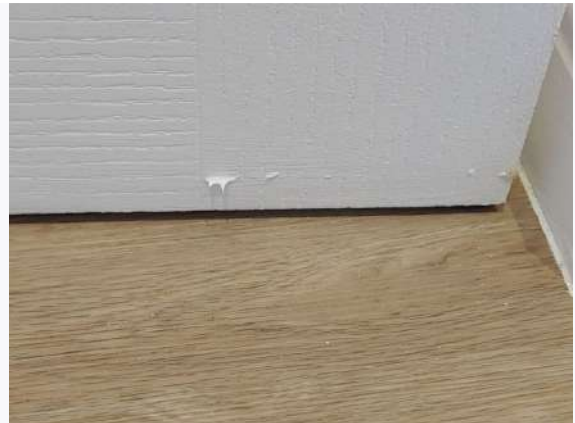
Ref # 13.2 - Scuff marks

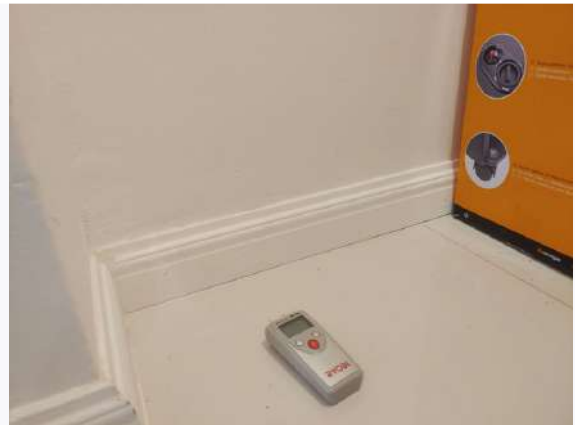
Ref # 15.1 - Active rising / lateral damp measured

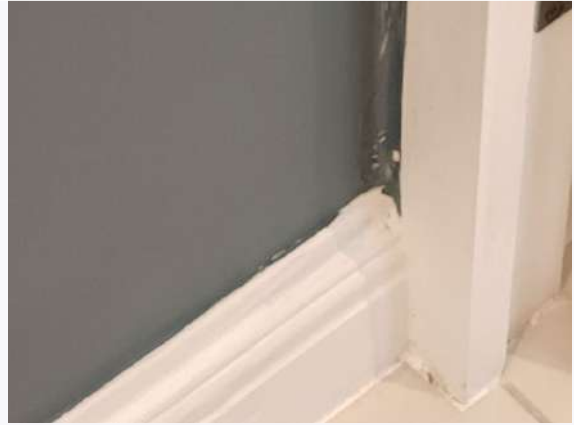
Ref # 15.1 - Untidy painting and finishing

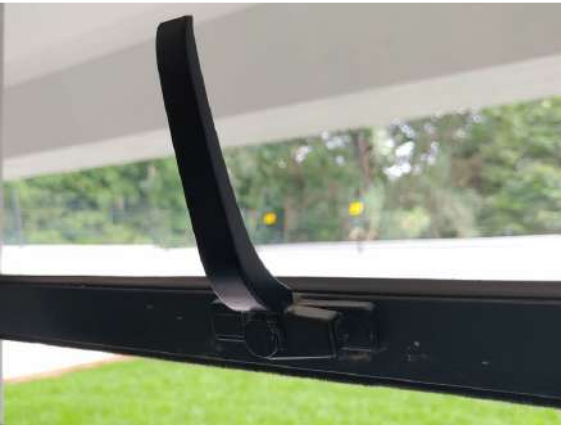
Ref # 15.2 - Window opener loose and requires adjustment

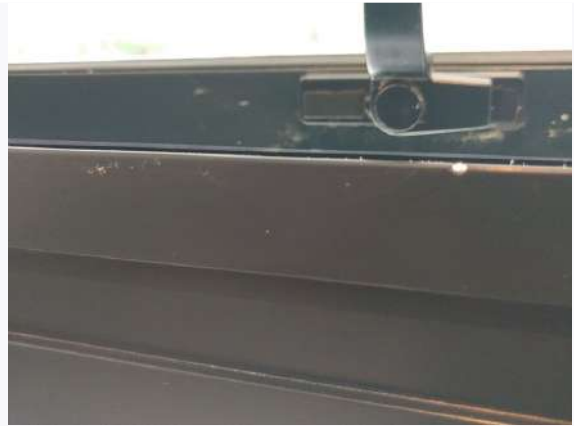
Ref # 15.2 - Window opener loose and requires adjustment

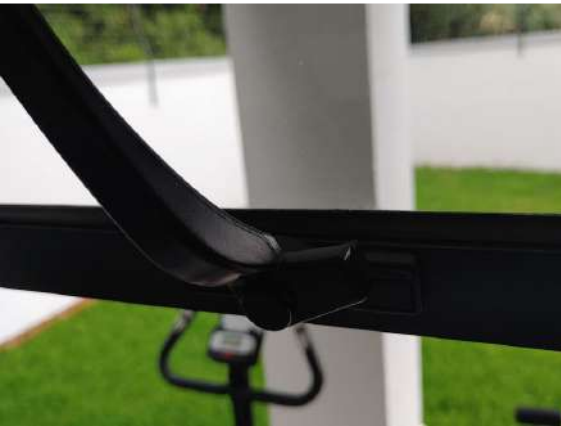
Ref # 15.2 - Window opener loose and requires adjustment

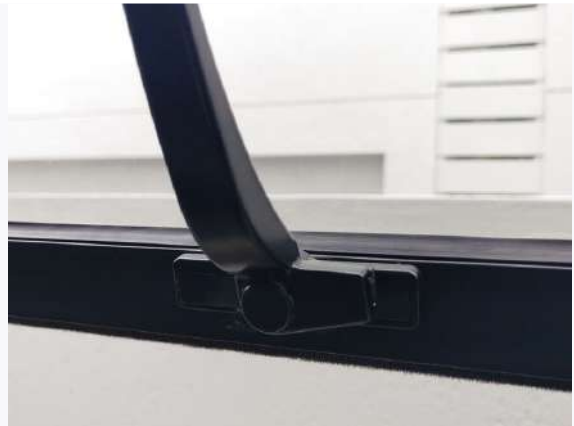
Ref # 15.2 - Window opener loose and requires adjustment

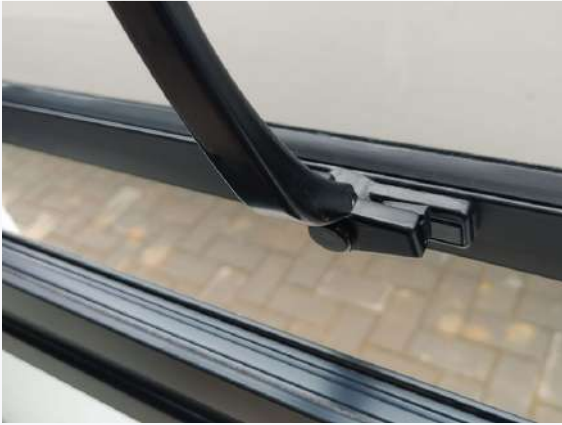
Ref # 15.2 - Window opener loose and requires adjustment

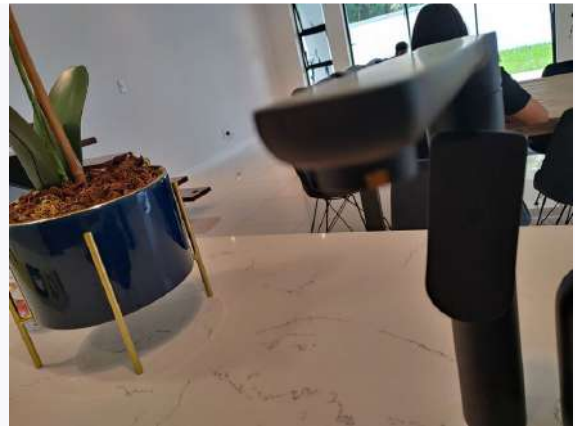
Ref # 16.3 - Mixer has scuff marks and chips

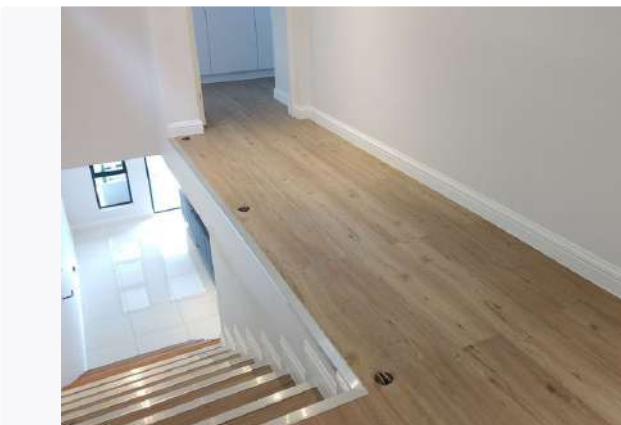
Ref # 17.2 - No balustrades

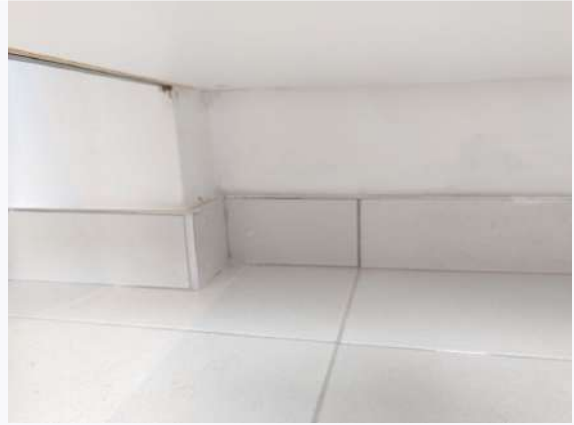
Ref # 18.1 - Untidy finishing

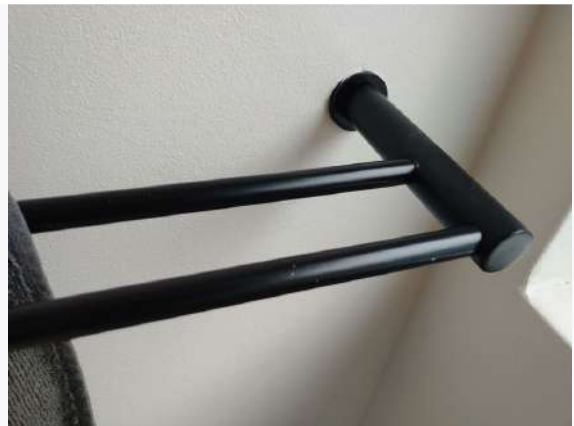
Ref # 18.1 - Paint splatter on towel rail

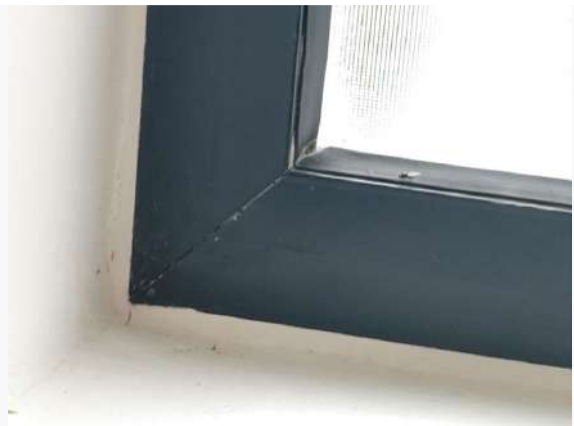
Ref # 18.2 - Gap at mitre joint

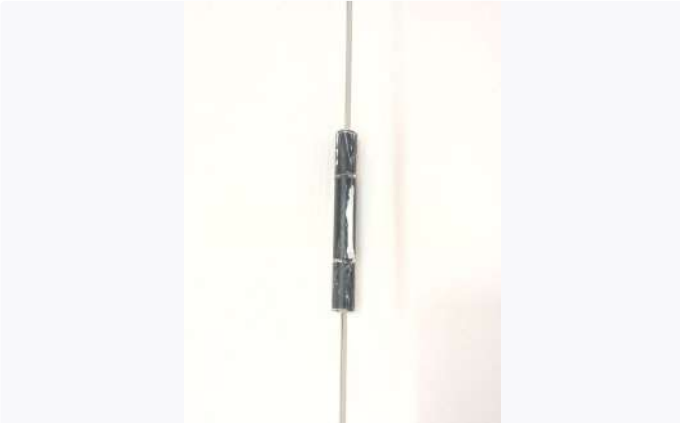
Ref # 18.3 - Untidy finishing

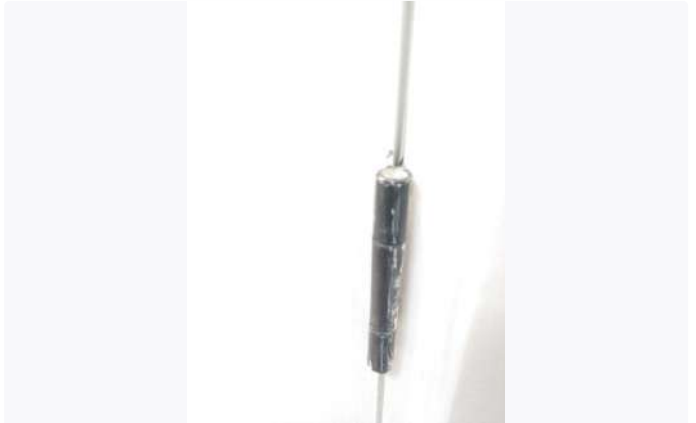
Ref # 18.3 - Untidy finishing

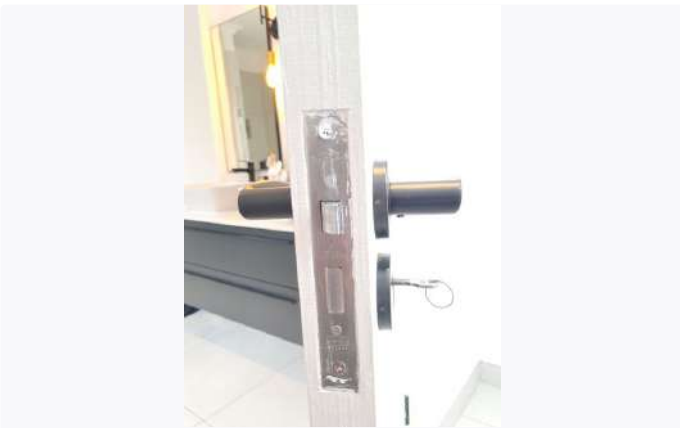
Ref # 18.3 - Paint splatter and scuff marks on the door lock sets

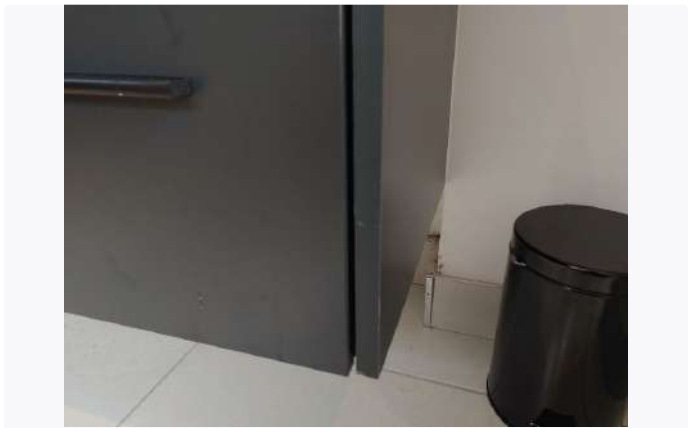
Ref # 18.4 - Paint splatter and scuff marks on the cupboard

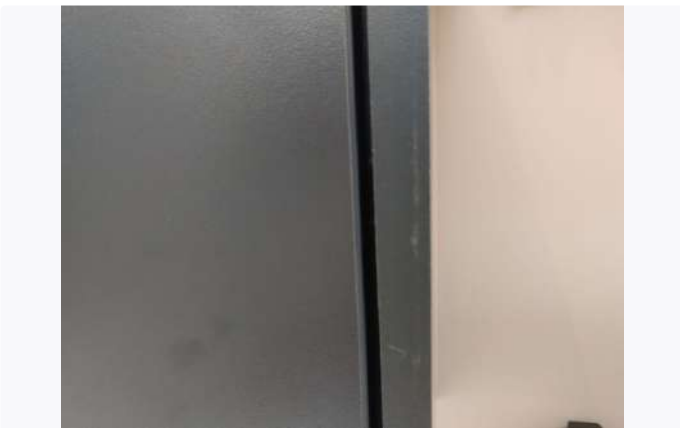
Ref # 18.4 - Paint splatter and scuff marks on the cupboard

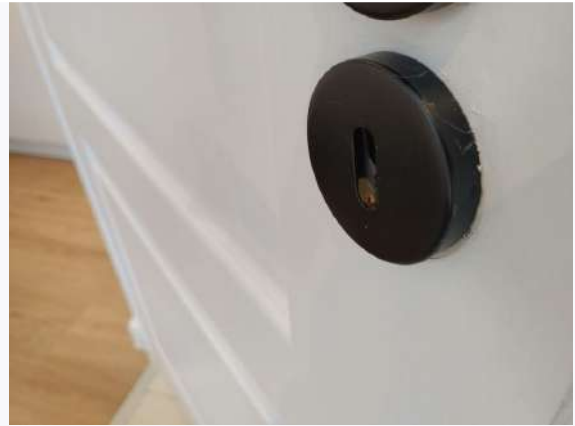
Ref # 19.1 - Paint splatter and scuff marks on the door lock sets

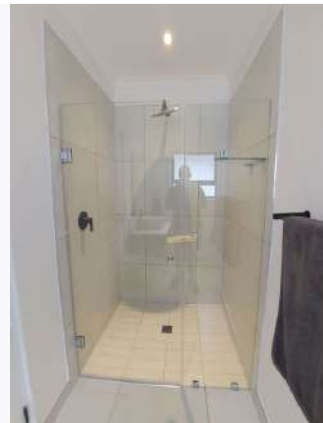
Ref # 19.4 - Shower door is too small and needs to be replaced

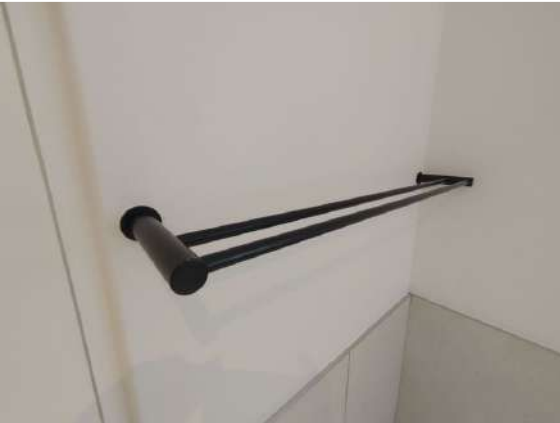
Ref # 20.1 - Towel rail is loose

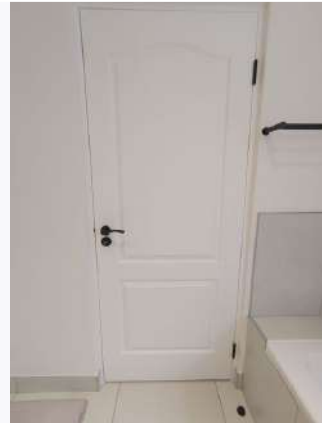
Ref # 20.2 - Door does not close properly

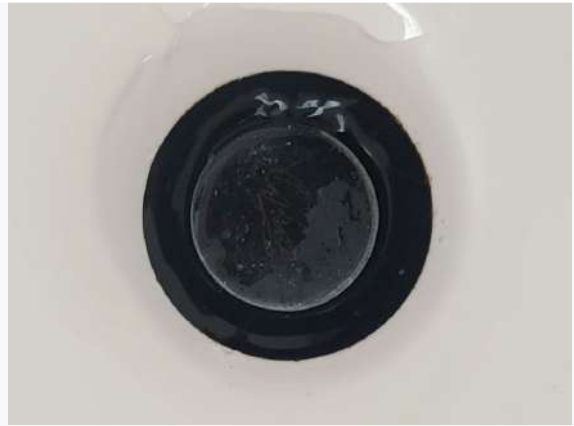
Ref # 20.4 - Pop-up drain plug has scuff marks

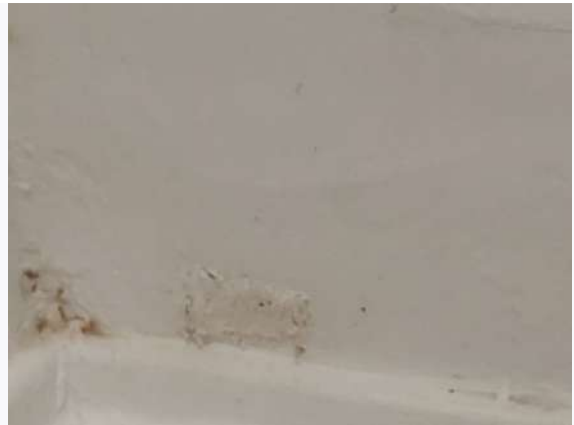
Ref # 21.1 - Wall with efflorescence

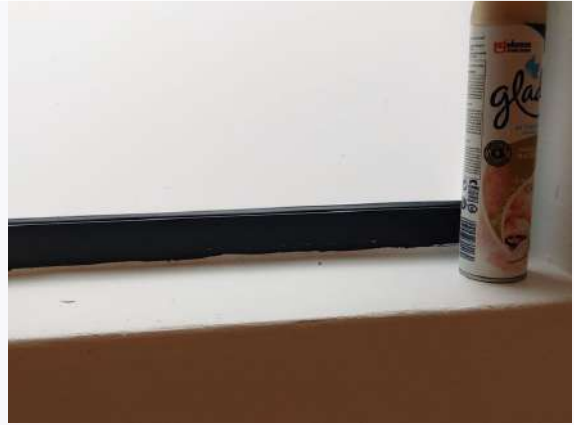
Ref # 21.2 - Untidy painting and finishing

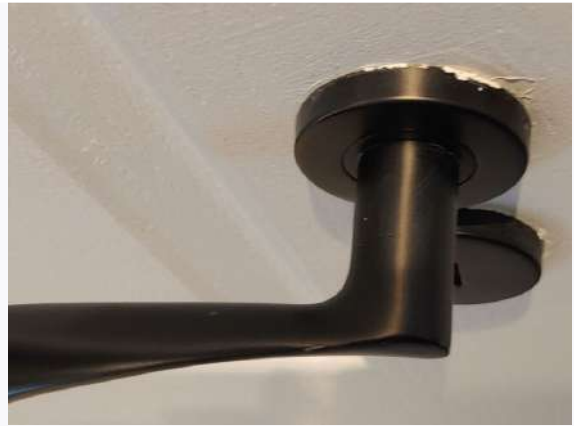
Ref # 21.3 - Paint splatter and scuff marks on the door lock sets

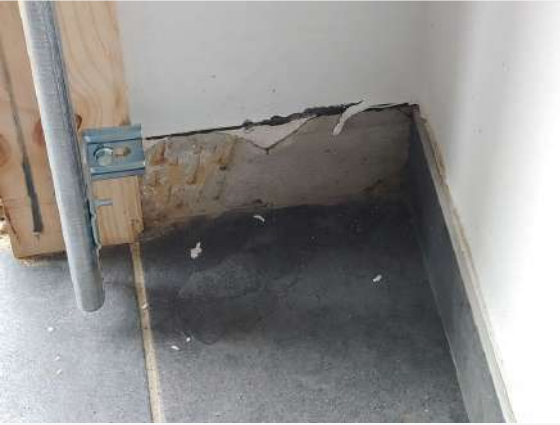
Ref # 22.4 - Tiled skirting missing

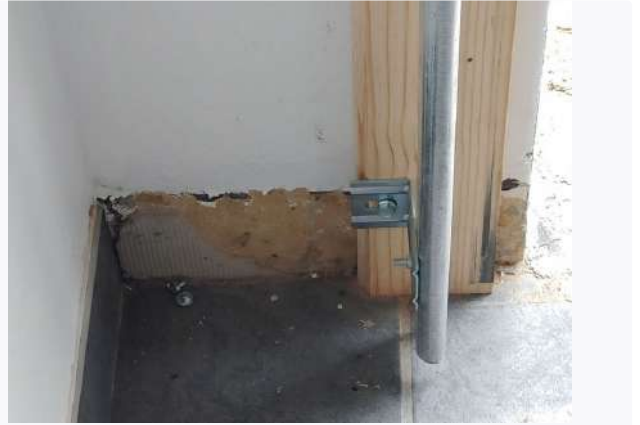
Ref # 22.4 - Tiled skirting missing

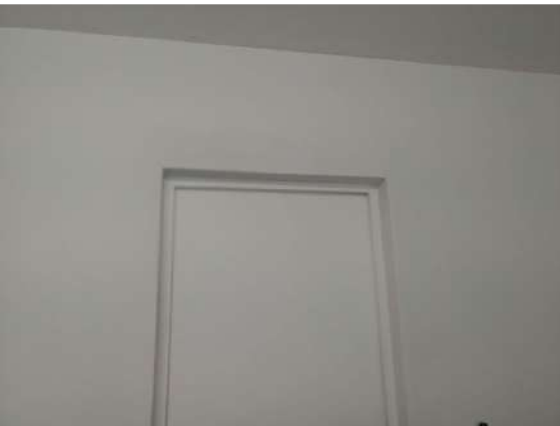
Ref # 22.4 - Untidy painting above fire door

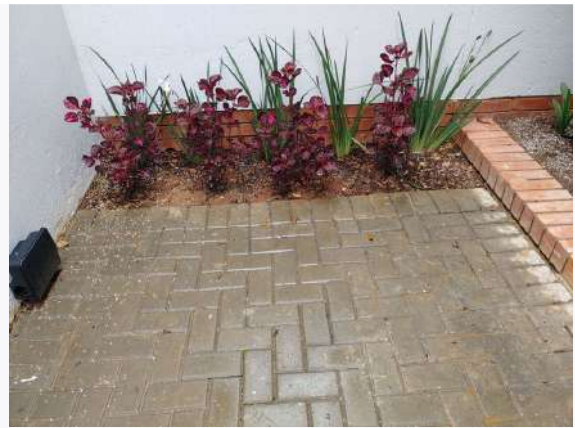
Ref # 23.1 - Evidence of storm water ponding near structures

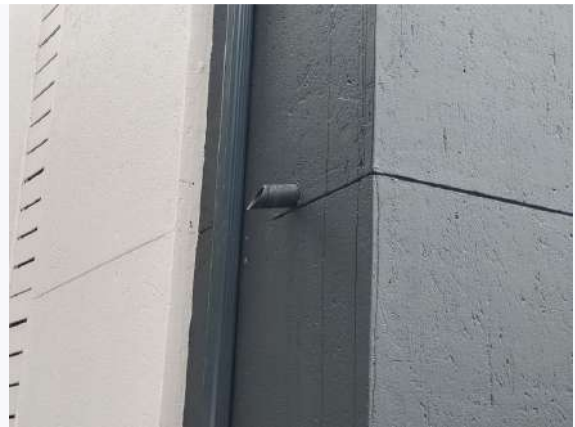
Ref # 23.1 - Downpipes and roof slab drainage is discharging soil at the base of the wal

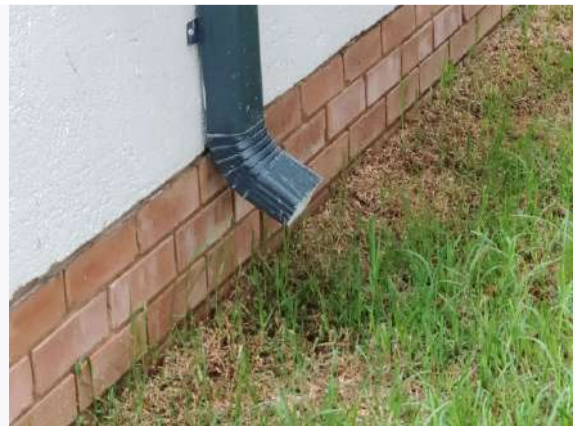
Ref # 23.1 - Downpipes is discharging onto unprotected soil at the base of the wall

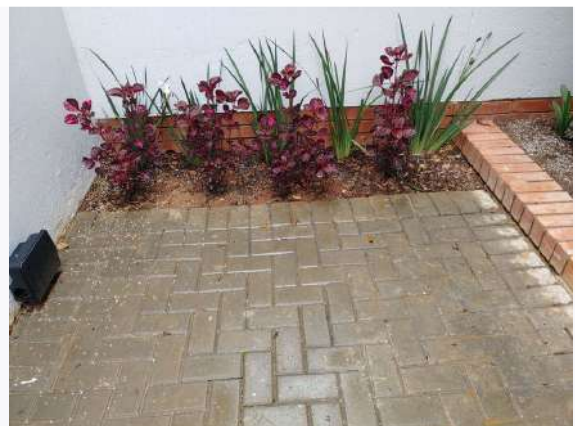
Ref # 23.3 - Weep holes for water run-off drainage is blocked and / or inadequate

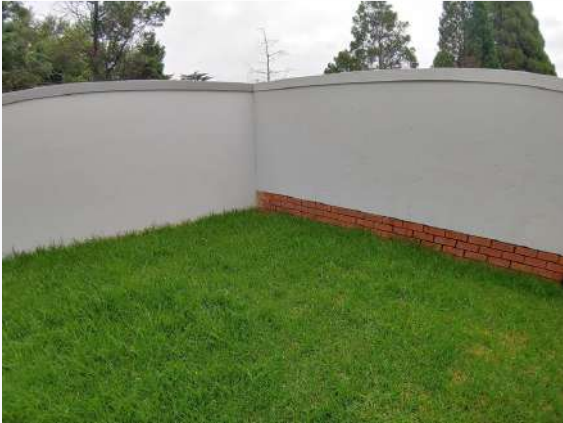
Ref # 23.3 - No weep holes

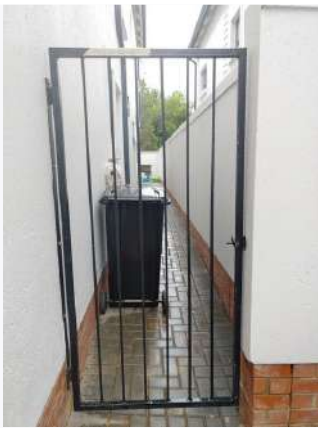
Ref # 23.4 - Gate rusted in places

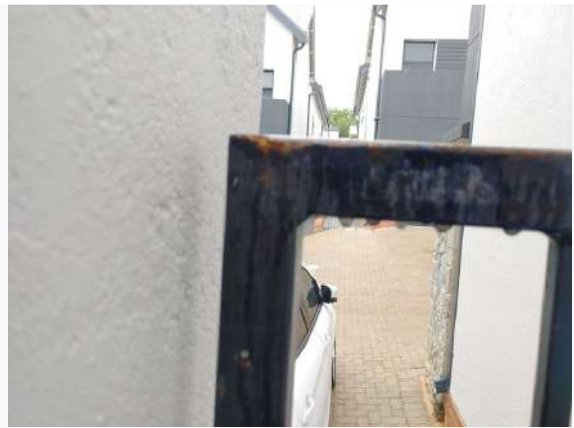
Ref # 23.4 - Gate rusted in places

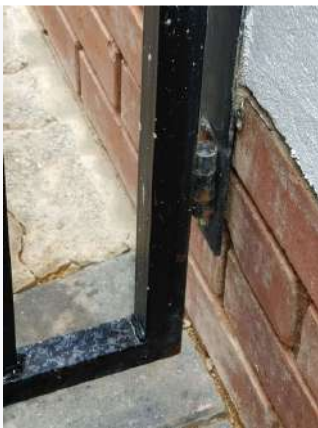
Ref # 23.4 - Gate rusted in places
