SNAG INSPECTION

Property address: SNAG INSPECTION SAMPLE REPORT
Johannesburg 0000

Date of inspection: 2022 / 02 / 16

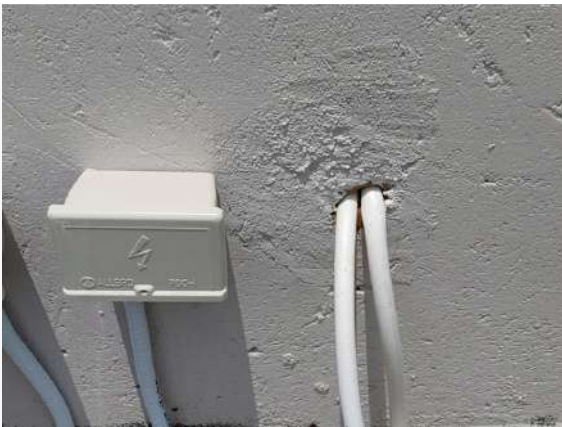
Ref # 2.1 - Untidy finish near geyser

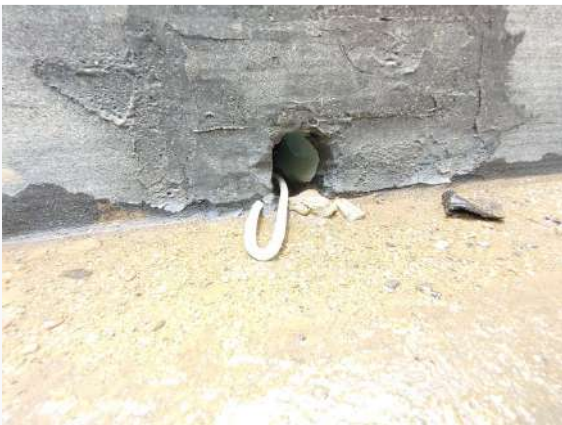
Ref # 4.1 - Drainage outlet is not effective

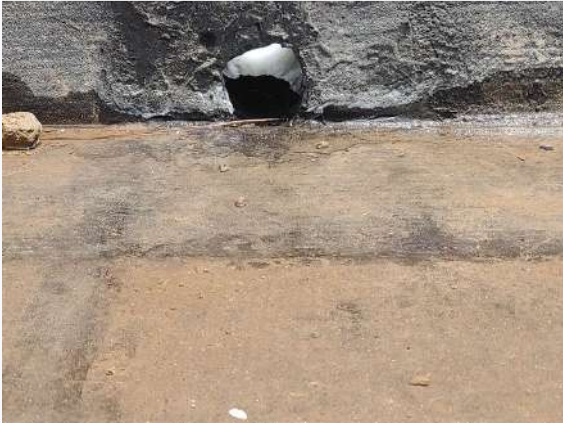
Ref # 4.1 - Drainage outlet is not effective

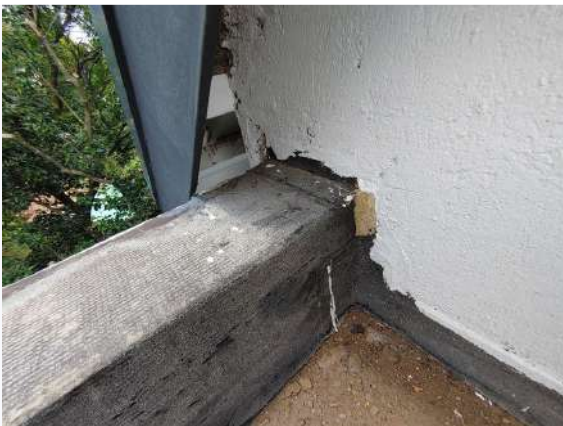
Ref # 4.2 - Areas not waterproofed

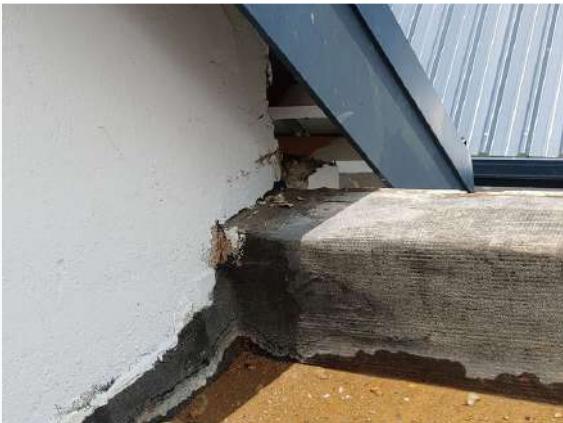
Ref # 4.2 - Areas not waterproofed

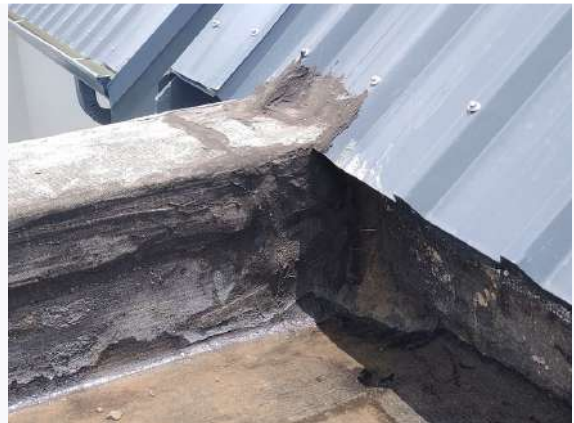
Ref # 4.2 - Waterproofing on parapet wall overlapping onto adjacent metal roof

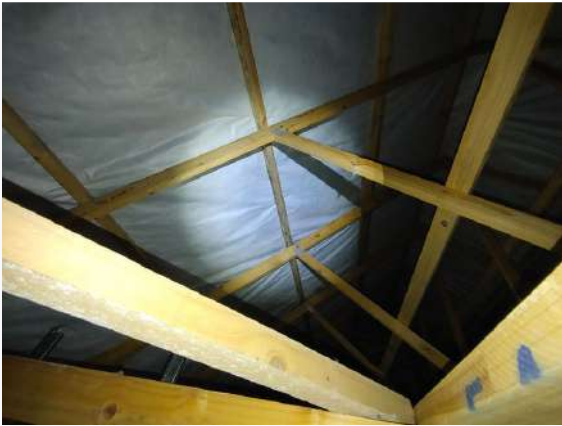
Ref # 5.2 - Roof underlay sheeting

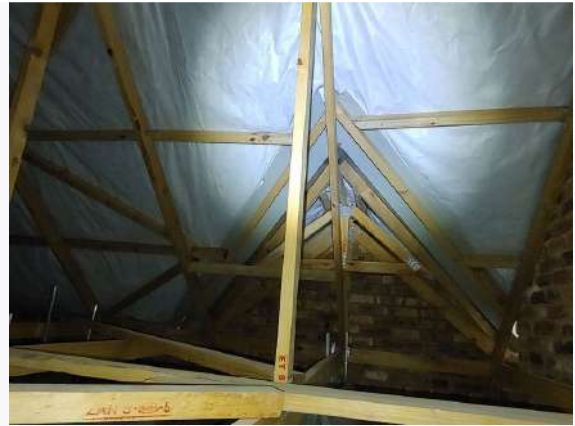
Ref # 5.2 - Roof underlay sheeting

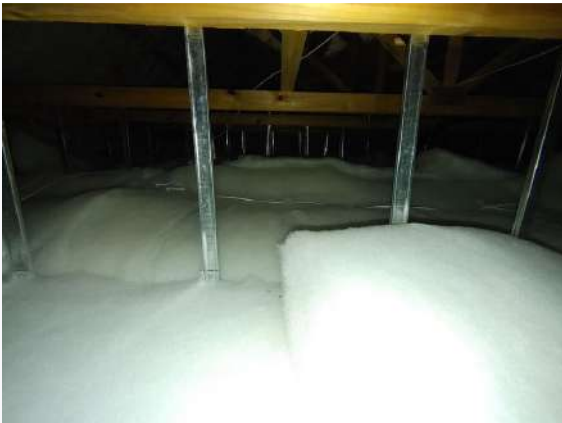
Ref # 5.3 - Roof insulation

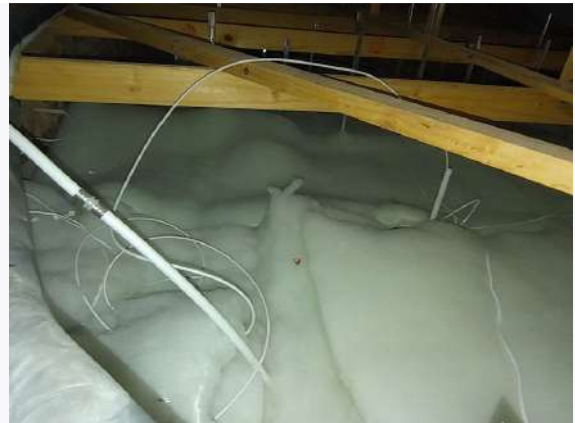
Ref # 5.3 - Roof insulation

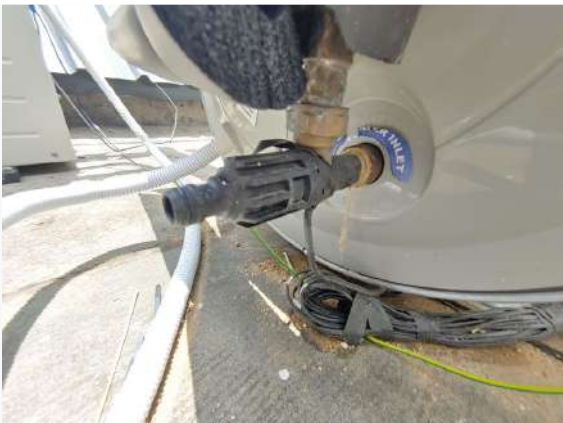
Ref # 6.3 - Electrical insulation tape wrapped around a fitting

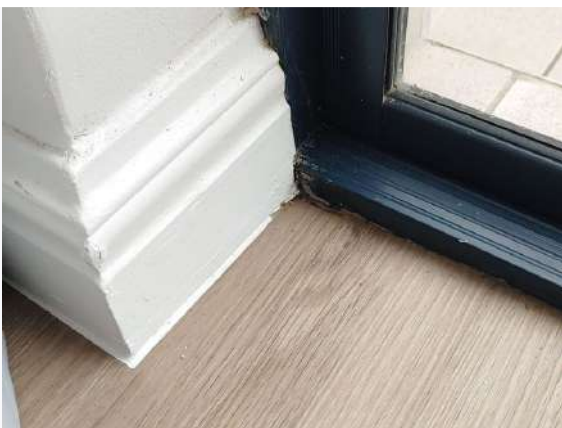
Ref # 10.1 - Untidy finish and no laminated cover strip

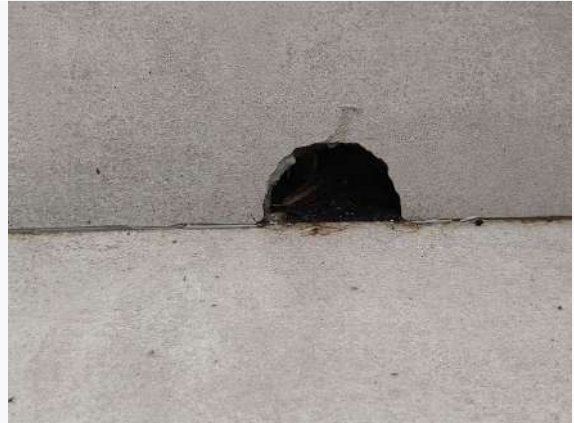
Ref # 10.2 - Drainage outlet appear to be to undersized

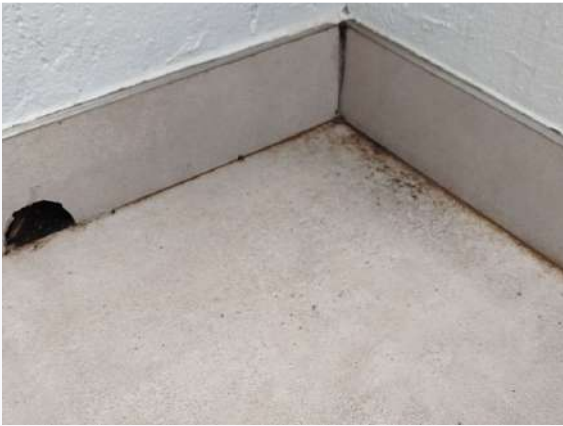
Ref # 10.2 - Areas where water is ponding

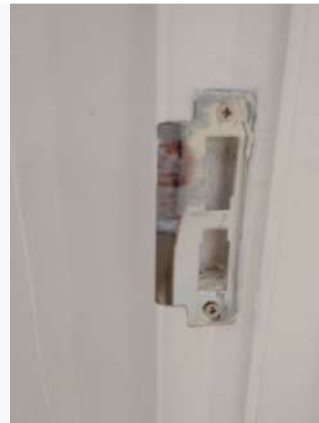
Ref # 10.3 - Untidy installation of striker plate

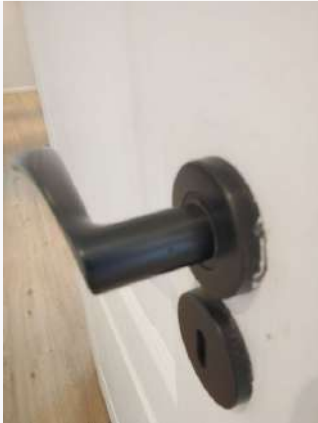
Ref # 10.3 - Paint splatter and scuff marks on the door lock sets

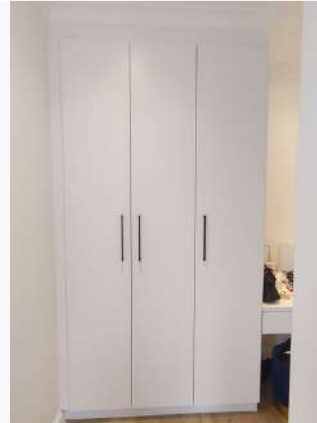
Ref # 10.4 - Cupboard doors and hinges require alignment and/or adjustment

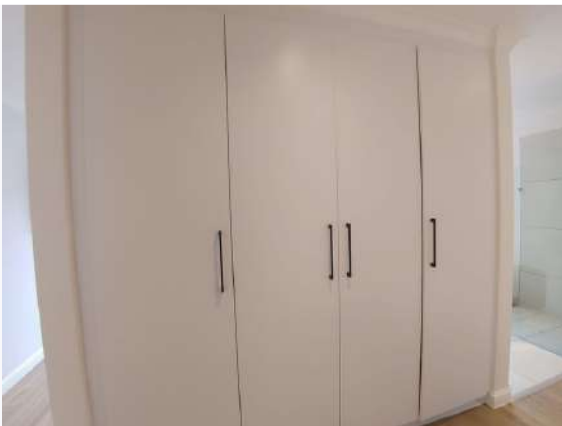
Ref # 10.4 - Cupboard doors and hinges require alignment and/or adjustment

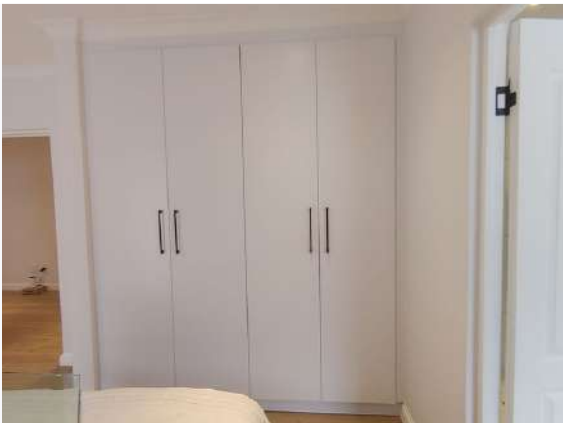
Ref # 11.4 - Cupboard doors and hinges require alignment and/or adjustment

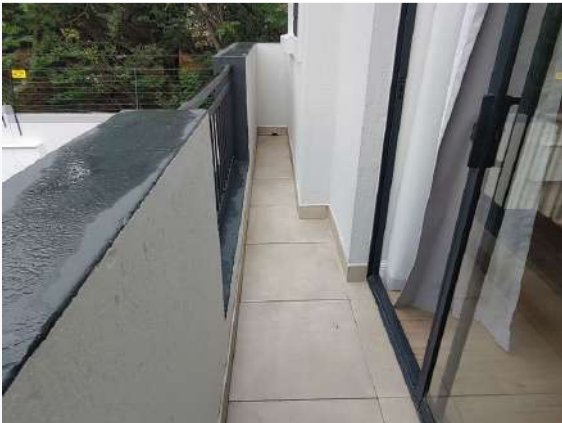
Ref # 12.1 - Verify if the balcony had been waterproofed

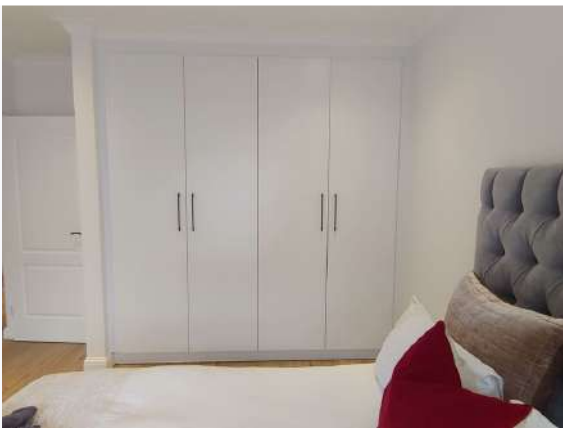
Ref # 12.3 - Cupboard doors and hinges require alignment and/or adjustment

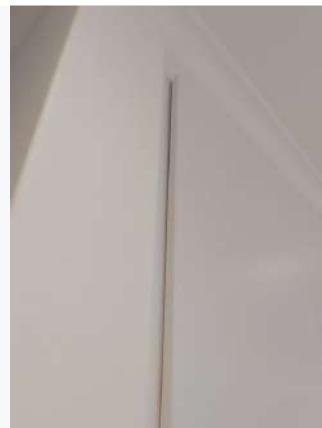
Ref # 12.3 - Cupboard doors and hinges require alignment and/or adjustment

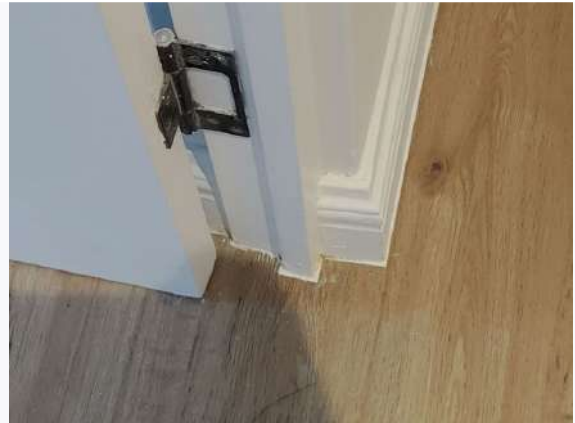
Ref # 14.1 - Untidy finishing at intersection to wall and floor

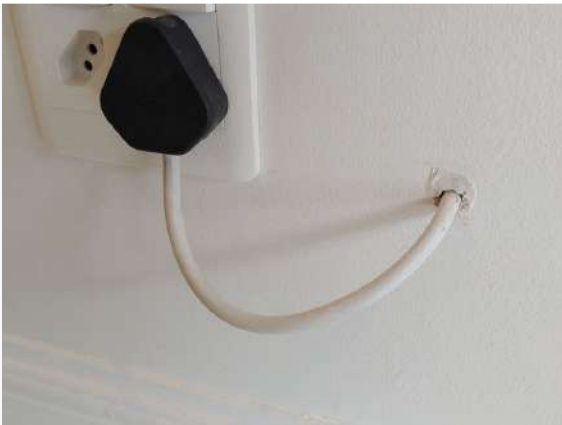
Ref # 15.1 - Hole drilled through wall for electrical flex cable

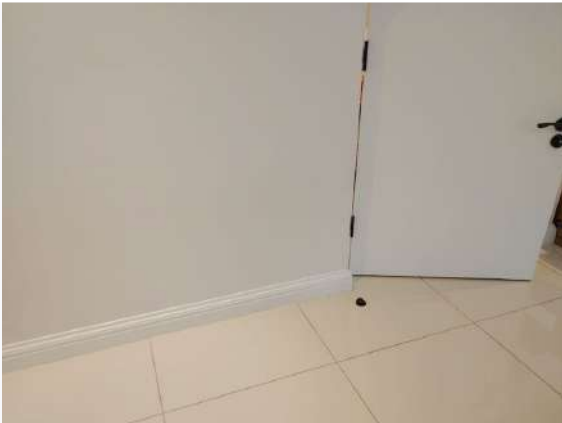
Ref # 15.1 - Active rising / lateral damp measured

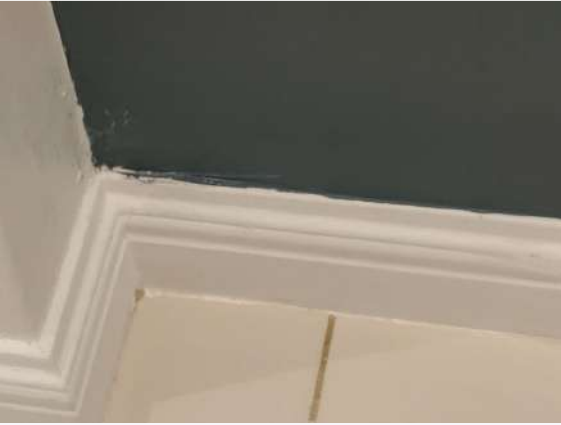
Ref # 15.1 - Untidy painting and finishing

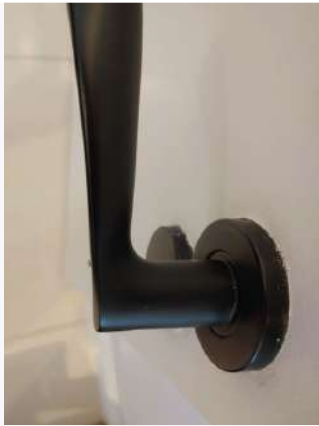
Ref # 15.3

15.2 Living Area » Windows (Interiors)	Window opener loose and requires adjustment	
15.3 Living Area » Doors (Interiors)	Paint splatter and scuff marks on the door lock sets; Door not closing properly, catching on door frame

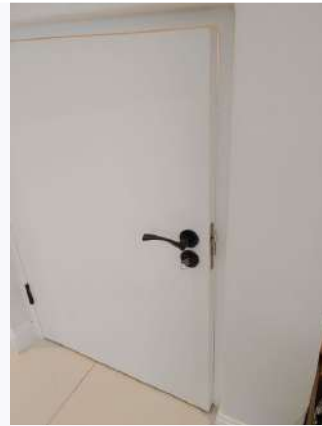
Ref # 15.3 - Door not closing properly

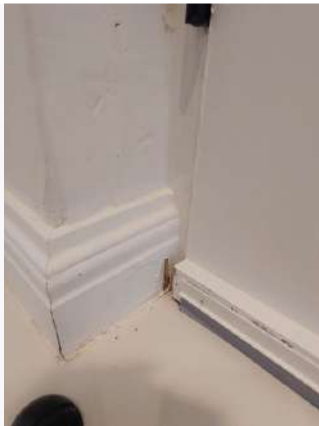
Ref # 15.4 - Door catching on skirting

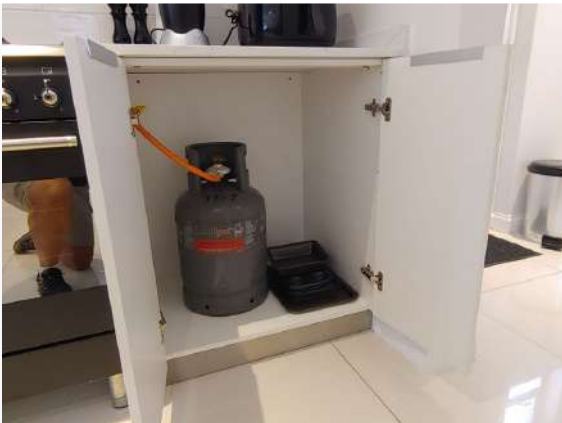
Ref # 16.1 - Floor unit housing the gas bottle is not ventilated

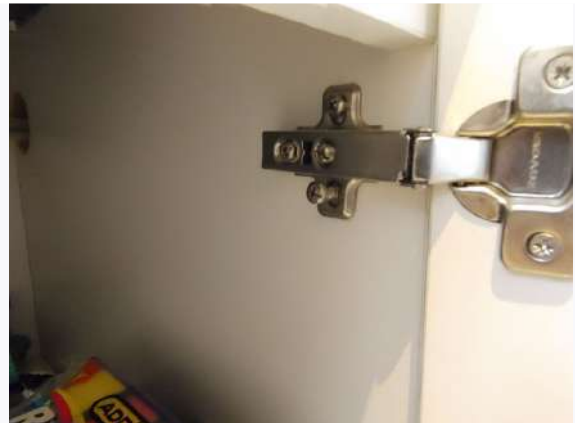
Ref # 16.1 - Hinge is not screwed in properly

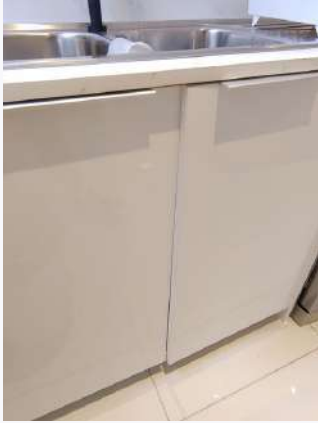
Ref # 16.1 - Door requires alignment

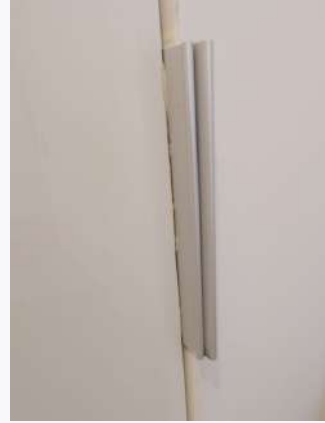
Ref # 16.1 - Untidy finishing

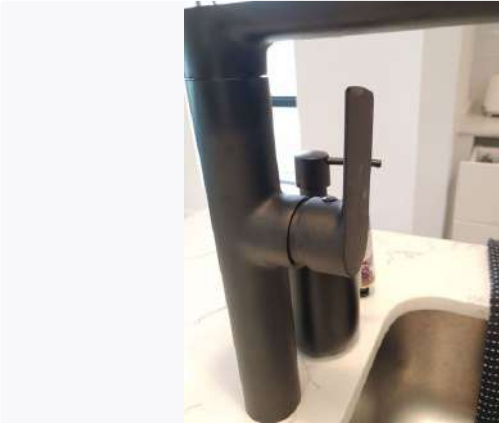
16.3	Prep bowl	Component Inspected; Mixer has scuff marks and chips DEFECTIVE ITEMS
16.4	Extractor hood	Observed - not tested
16.5	Built-in oven	Observed - not tested
16.6	Stove hob	Observed - not tested

Ref # 16.3 - Mixer has scuff marks and chips

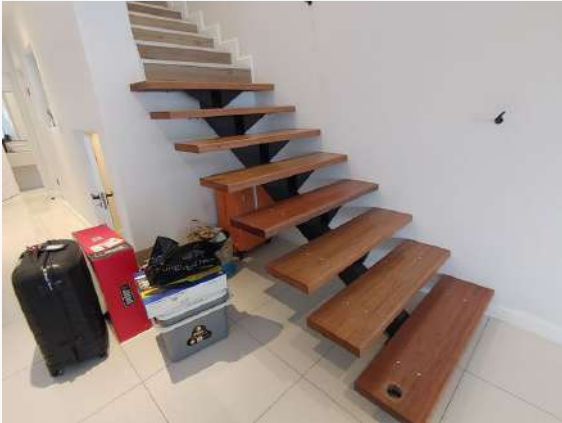
Ref # 17.2 - No balustrades

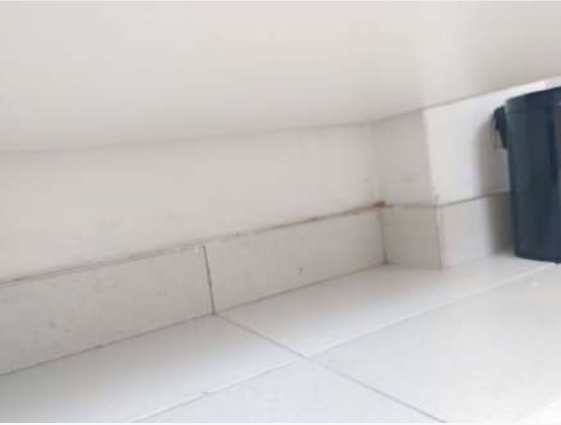
Ref	Inspectors Notes	Comment
18.1	Walls	Untidy finishing below floating vanity; Paint splatter on towel rail DEFECTIVE ITEMS
18.2	Windows (Interiors)	Day light can be seen through the mitre joints of the Aluminium window frame DEFECTIVE ITEMS
18.3	Doors (Interiors)	Paint splatter and scuff marks on the door lock sets and hinges DEFECTIVE ITEMS
18.4	Cupboards	Paint splatter and scuff marks on the cupboard DEFECTIVE ITEMS

Ref # 18.1 - Untidy finishing

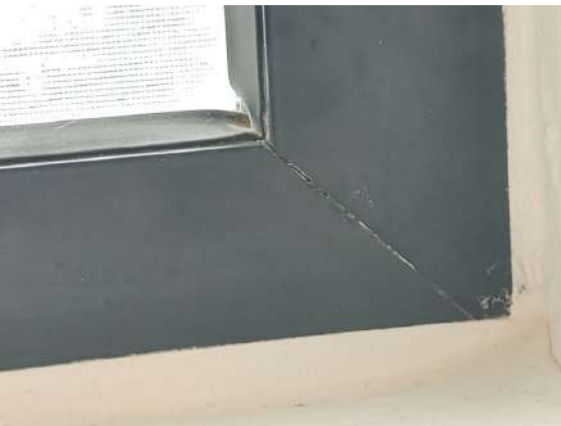
Ref # 18.2 - Gap at mitre joint

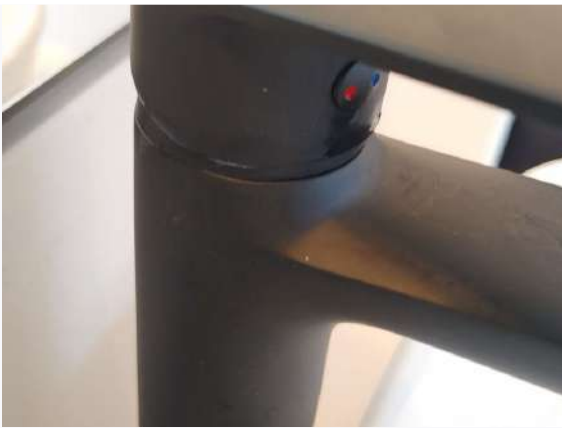
18.5	Basin 1 & 2	Mixer has scuff marks and paint splatter DEFECTIVE ITEMS
18.6	Shower	Mixer has scuff marks; It should be verified by the contractor if the shower floor and walls had been waterproofed to the height of the shower rose DEFECTIVE ITEMS

Ref # 18.5 - Mixer has scuff marks

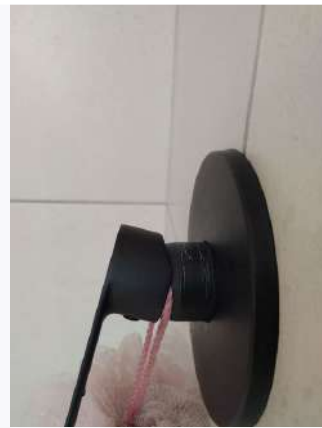
Ref # 18.6 - Mixer has scuff marks

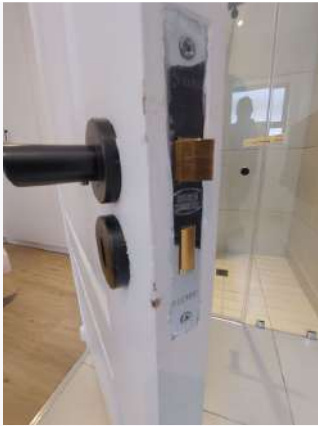
Ref	Inspectors Notes	Comment
19.1	Doors (Interiors)	Paint splatter and scuff marks on the door lock sets; Door does not close properly DEFECTIVE ITEMS
Sanitaryware		
19.2	Basin 1	Component Inspected
19.3	Toilet	Untidy finishing behind the toilet and outlet pipe DEFECTIVE ITEMS
19.4	Shower	Shower door is to small and needs to be replaced; It should be verified by the contractor if the shower floor and walls had been waterproofed to the height of the shower rose INCOMPLETE WORKS

Ref # 19.1 - Paint splatter and scuff marks on the door lock sets

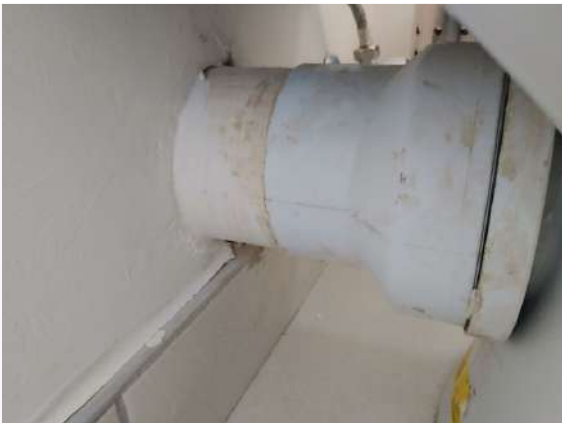
Ref # 19.3 - Untidy finishing behind the toilet and outlet pipe

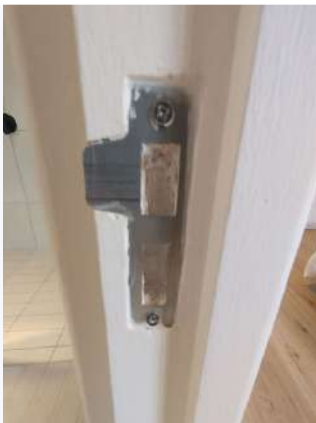
Ref	Inspectors Notes	Comment
20.1	Walls	Towel rail is loose DEFECTIVE ITEMS
20.2	Doors (Interiors)	Paint splatter and scuff marks on the door lock sets; Door does not close properly DEFECTIVE ITEMS

Ref # 20.2 - Untidy installation of striker plate

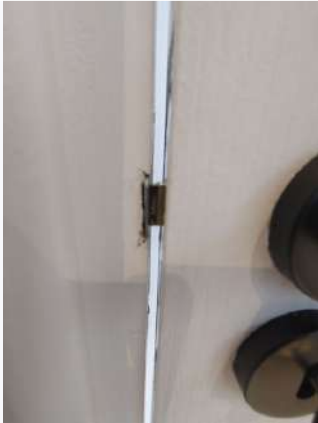
Ref # 20.2 - Door does not close properly

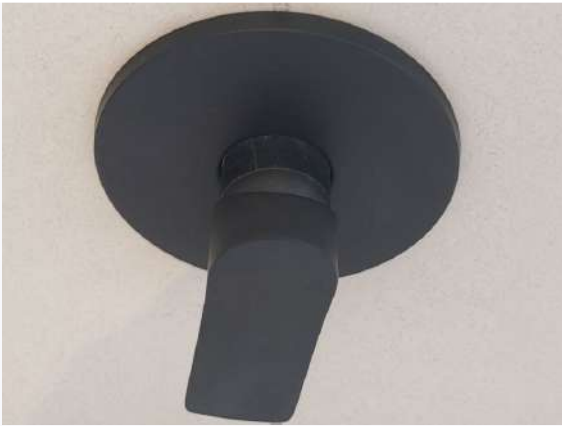
20.3	Basins	Component Inspected
20.4	Bath	Mixer has scuff marks and paint splatter; Pop-up drain plug has scuff marks DEFECTIVE ITEMS

Ref # 20.4 - Mixer has scuff marks

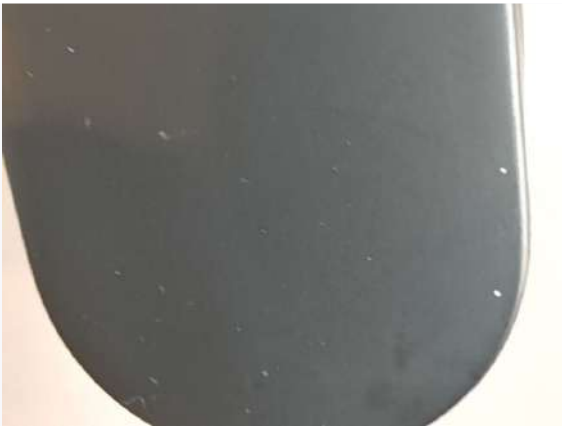
Ref # 20.4 - Mixer has paint splatter

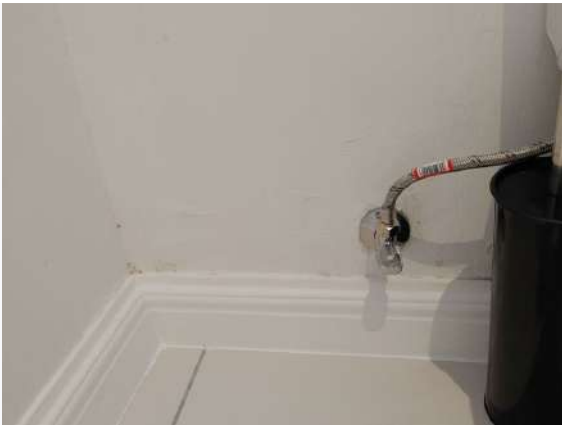
Ref	Inspectors Notes	Comment
21.1	Walls	Active rising / lateral damp measured; Wall with blistering or flaking paint; Wall with efflorescence (salt deposits) DEFECTIVE ITEMS
21.2	Windows (Interiors)	Untidy painting and finishing DEFECTIVE ITEMS

Ref # 21.1 - Active rising / lateral damp measured

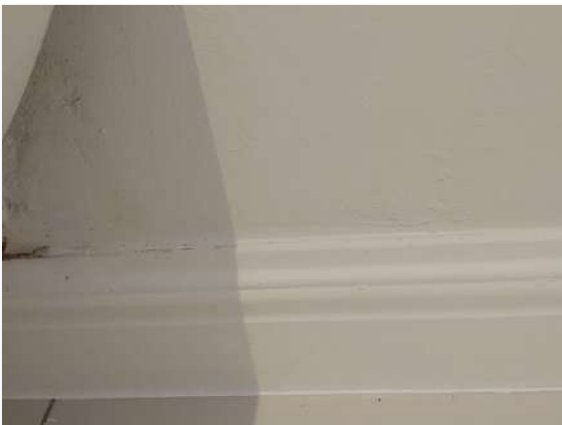
Ref # 21.1 - Active rising / lateral damp measured

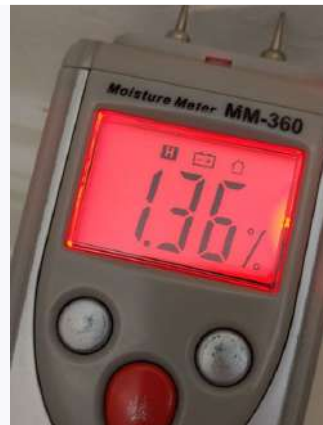
Ref # 21.1 - Active rising / lateral damp measured

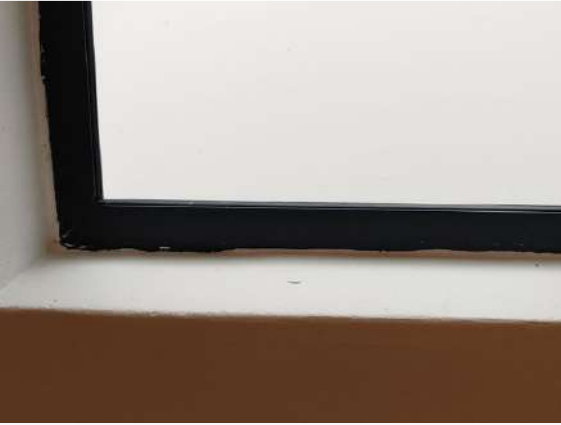
Ref # 21.2 - Untidy painting and finishing

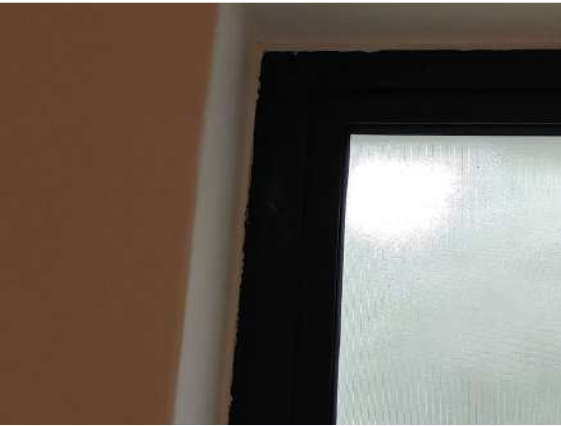
Ref # 21.2 - Untidy painting and finishing

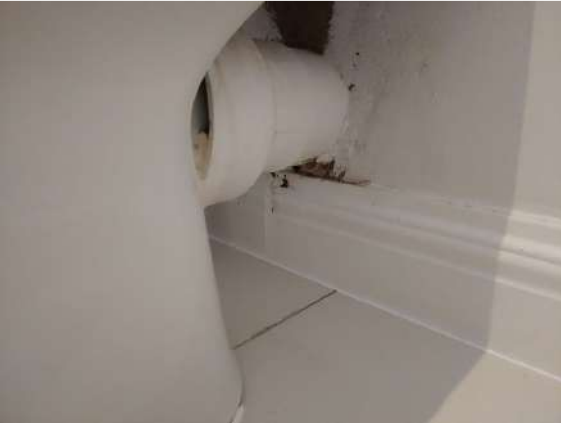
21.4	Basin	Component Inspected
21.5	Toilet	Untidy finishing behind the toilet and outlet pipe DEFECTIVE ITEMS

Ref # 21.5 - Untidy finishing behind the toilet and outlet pipe

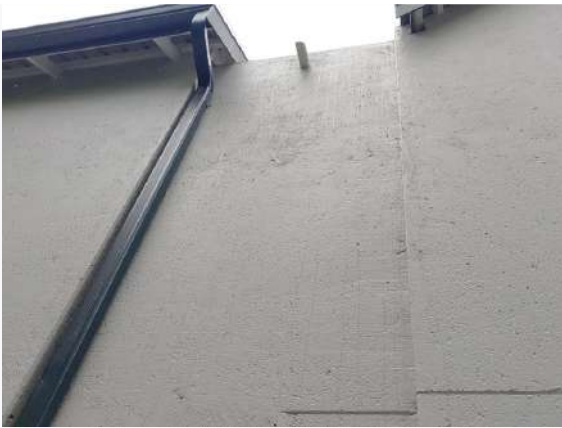
Ref	Inspectors Notes	Comment
Stormwater Management		
23.1	Stormwater management	No adequate drainage away from structures not provided; Downpipes and roof slab drainage is discharging onto unprotected paving and / or soil at the base of the wall; Evidence of storm water ponding near structures; Stormwater appears to pond against free-standing walls; Stormwater does not drain effectively away from structures and off the property DEFECTIVE ITEMS
23.2	Gradient of ground	Steep gradient; Stormwater drains towards structures
Walls & Fences		
23.3	Boundary walls	No weep holes for water run-off drainage provided; Weep holes for water run-off drainage is blocked and / or inadequate DEFECTIVE ITEMS
23.4	Pedestrian gate	Gate rusted in places DEFECTIVE ITEMS

Ref # 23.1 - Roof slab drainage is discharging onto unprotected paving at the base of th

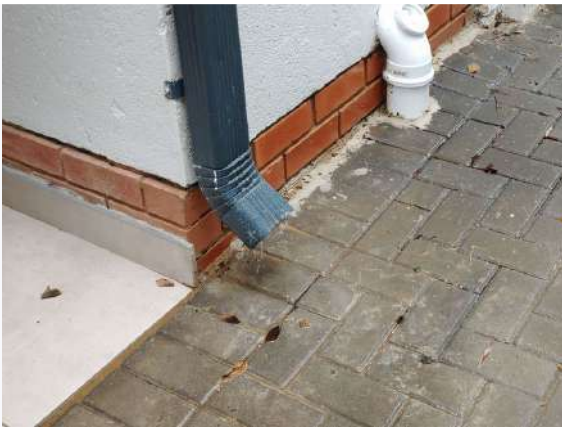
Ref # 23.1 - Downpipes and roof slab drainage is discharging onto unprotected paving at

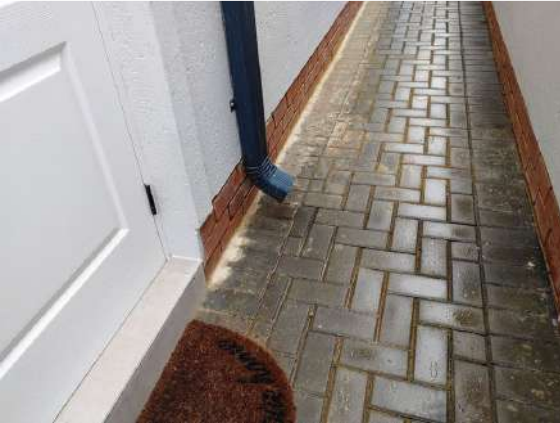
Ref # 23.1 - Downpipes and roof slab drainage is discharging onto unprotected paving at

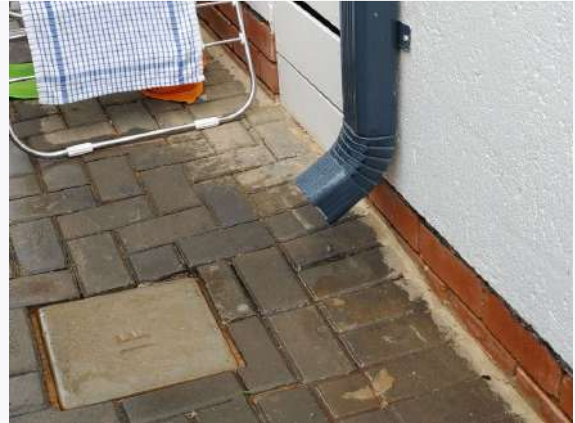
Ref # 23.1 - Downpipes and roof slab drainage is discharging onto unprotected paving at

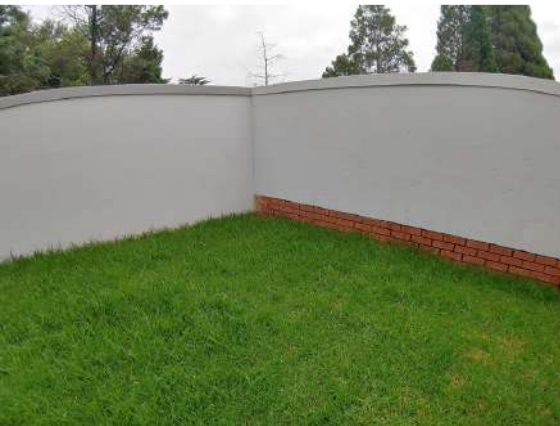
Ref # 23.1 - Evidence of storm water ponding near structures

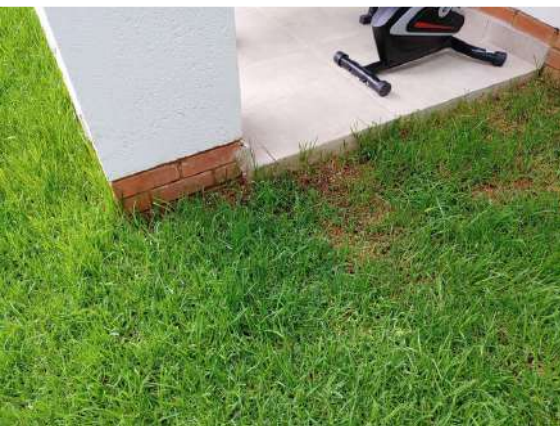
Ref # 23.1 - Roof slab drainage is discharging onto unprotected soil at the base of the

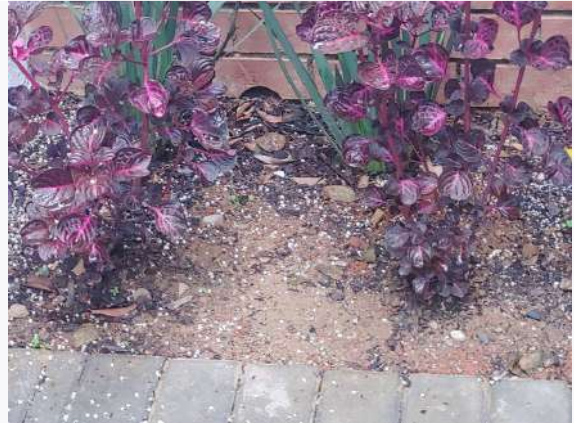
Ref # 23.3 - Weep holes for water run-off drainage is blocked
