SNAG INSPECTION

Property address: SNAG INSPECTION SAMPLE REPORT
Johannesburg 0000

Date of inspection: 2022 / 02 / 16

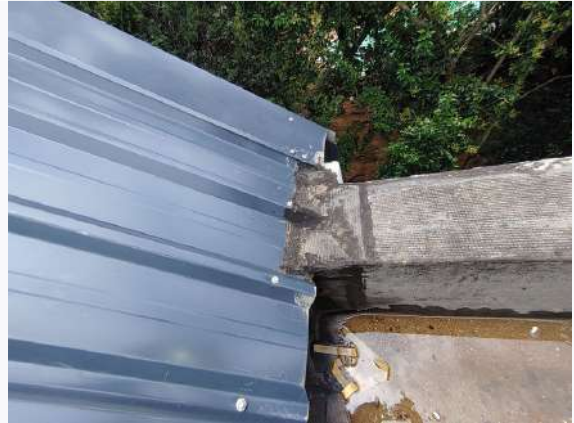
Ref # 4.2 - Waterproofing on parapet wall overlapping onto adjacent metal roof

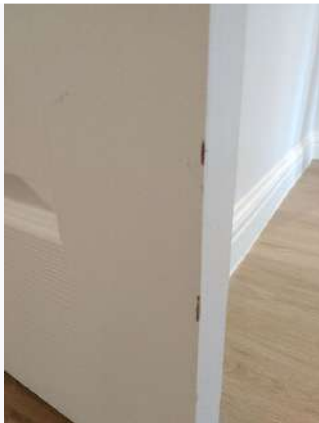
Ref # 10.3 - Scuff marks

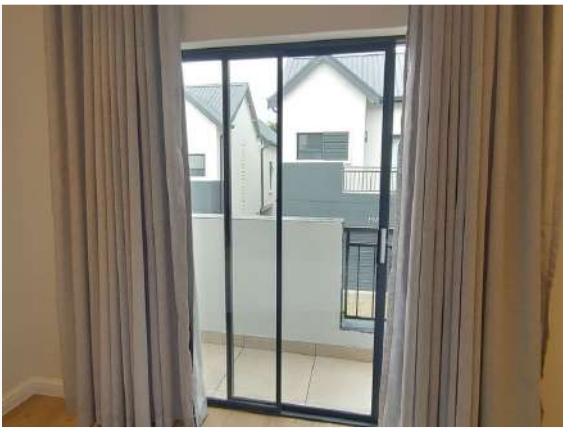
Ref # 12.2 - Sliding door not sliding smoothly

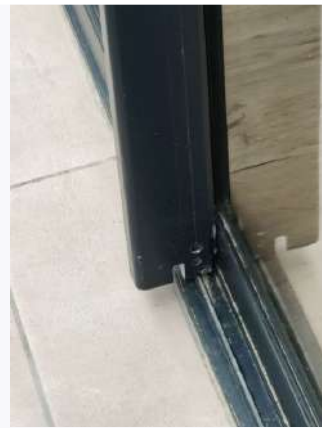
Ref # 12.2 - Sliding door not sliding smoothly

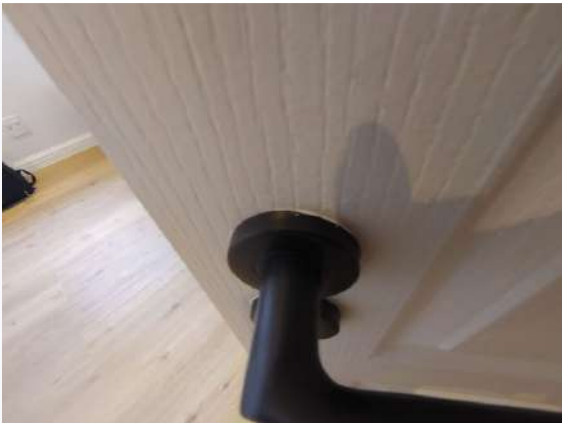
Ref # 13.2 - Paint splatter and scuff marks on the door lock sets

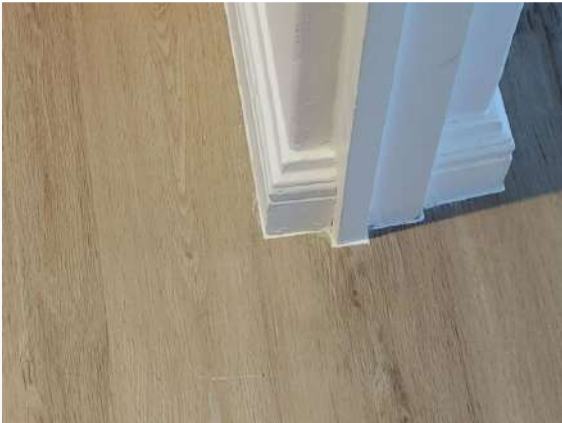
Ref # 14.1 - Untidy finishing at intersection to wall and floor

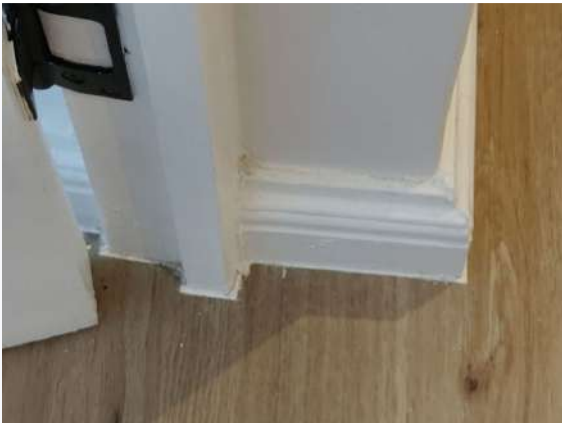
Ref # 14.1 - Untidy finishing at intersection to wall and floor

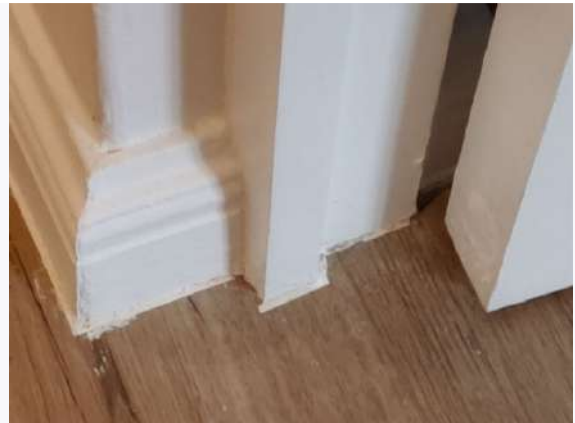
Ref # 14.1 - Untidy finishing at intersection to wall and floor

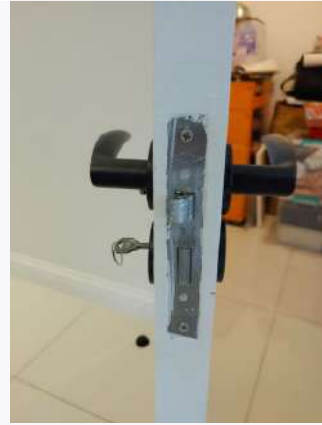
Ref # 15.3

15.2 Living Area » Windows (Interiors)	Window opener loose and requires adjustment	
15.3 Living Area » Doors (Interiors)	Paint splatter and scuff marks on the door lock sets; Door not closing properly, catching on door frame

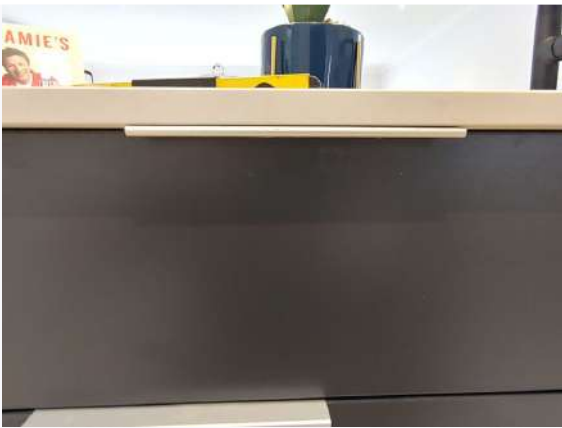
Ref	Inspectors Notes	Comment
16.1	Cupboards	Cupboard doors, drawers and hinges require final alignment and/or adjustment; Hinge screws missing and /or not screwed in properly; Untidy finishing areas; Floor unit housing the gas bottle is not ventilated DEFECTIVE ITEMS
16.2	Sink 1	Component Inspected

Ref # 16.1 - Drawer catching on counter top
